REINFORCING SIDE DECKS

REINFORCING SIDEDECKS: s/v Gracie Emmett DE32

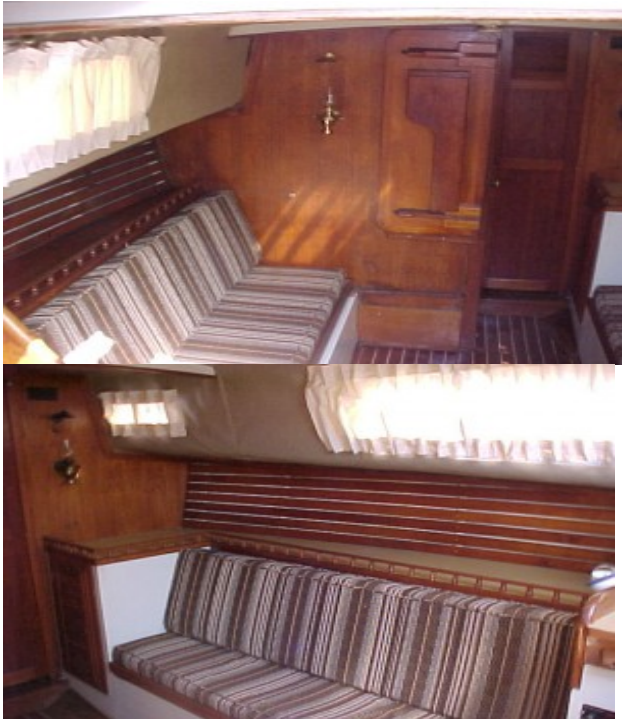
The side deck sections along the cabin area have clear spans with no bulkheads or built-in cabinets to give support to the underside of the side decks. These deck areas always flexed, a condition that was attributed to lack of support.

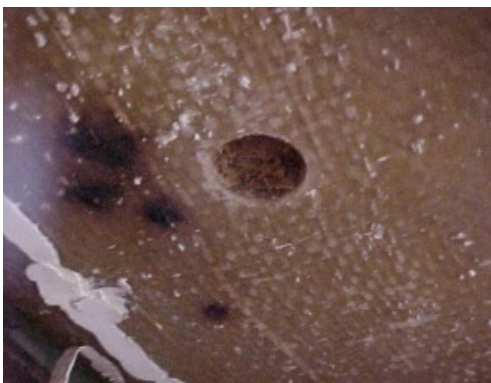
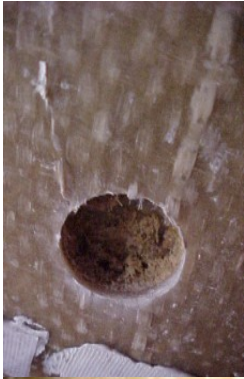
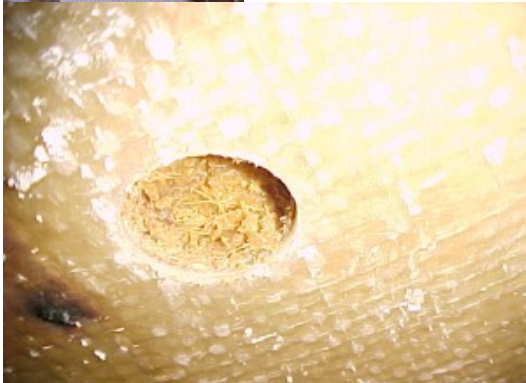
Recently, a prospective buyer was convinced that the flex in the deck was a sign of deck delamination and core deterioration. Within days, a fiberglass expert was called in to assess the situation. Several core samples were taken on each side of these areas, which concluded that there was no delamination or core deterioration.

However, the thickness of the fiberglass and core on these sections of the side decks was relatively thin, approximately $\frac{1}{2}$ ", which was surprising because when installing a cabin top head vent, chain deck pipes, and the cockpit hatch, the core samples were much thicker ($\frac{3}{4}$ " - 1").

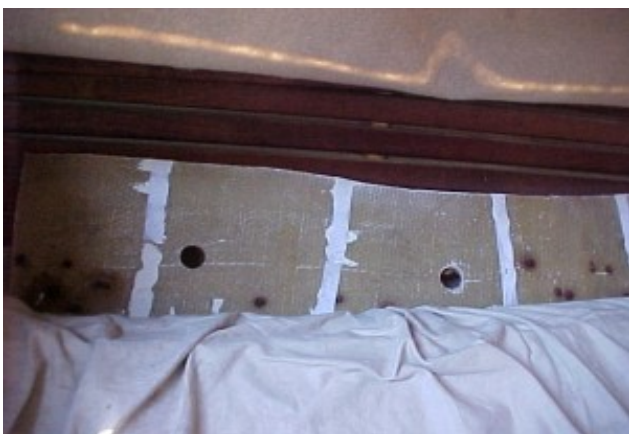
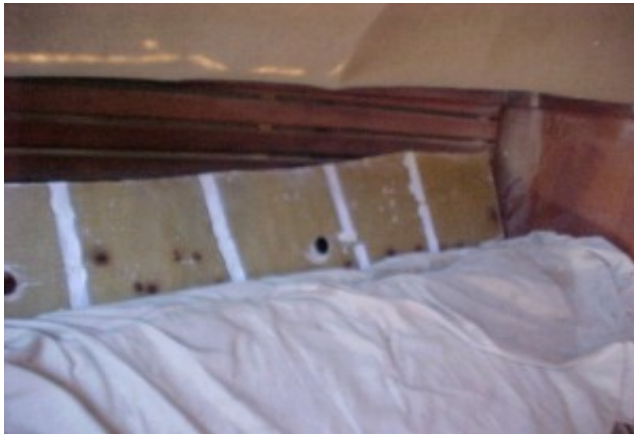
Once the panel was removed, the entire core was inspected and probed. (If moisture is found, eliminate the source of water intrusion, and allow the core to dry.) The "Corelite" core material is closed cell impregnated with glass fibers, and very resilient. (Removal of the Corelite was considered at one point, but a few minutes with a chisel and hammer quickly dissuaded this course of action— the Corelite was sound and could not be improved upon.)

The approach taken for this project was to remove the interior layer of fiberglass and reinforce the side decks from the underside. This approach was made much easier as the result of the removable Spectropile headliner that was installed (see recent Gracie Emmett headliner article), and the fact that there were no interior built-ins that had to be dismantled. Step one was to cut and remove the interior layer of fiberglass below deck.

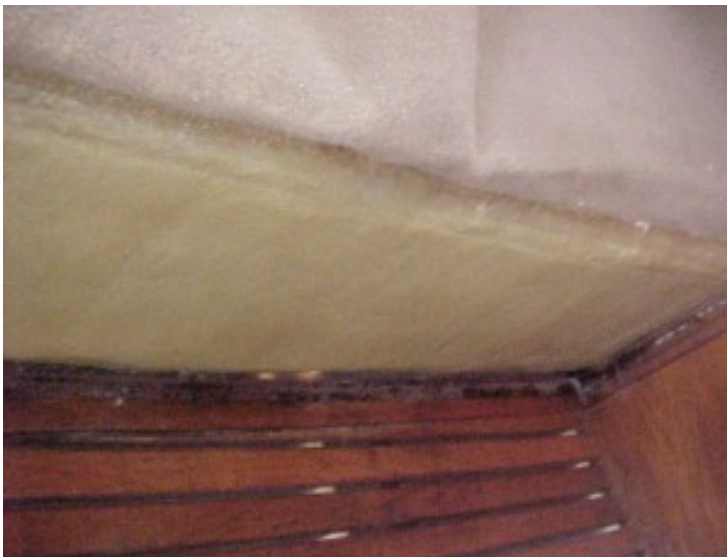
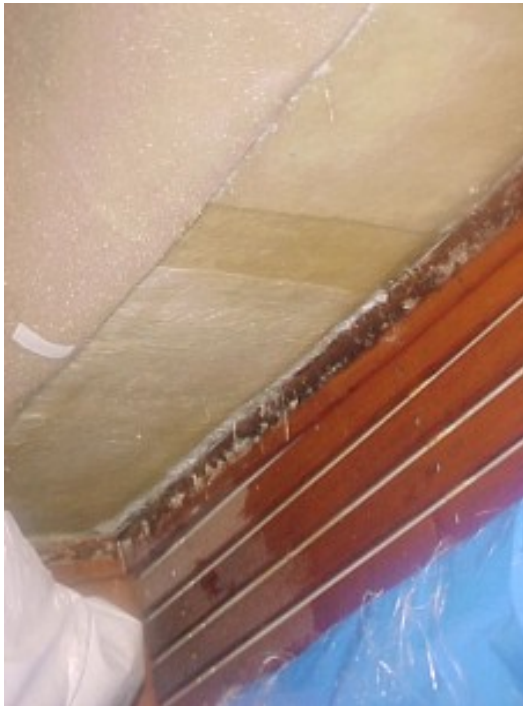
The result was excellent. After the first coat of epoxy putty had cured, the flex in the side deck was eliminated. The finished project completely restored the structural integrity to the side decks, and provided an opportunity to thoroughly inspect the condition of these areas, removing any doubt as to the condition of the side decks. Finally, instead of using 5200 caulk and stainless steel staples to secure the Velcro strips used to reattach the Spectropile headliner material, the Velcro strips were embedded with epoxy putty, which was much easier and cost/labor effective.

This first coat was allowed to cure, and a second coat of epoxy putty was applied, after grinding the surfaces of surrounding fiberglass and putty. Then the first layer of fiberglass mat, wetted with 1:1 resin (Laminating Epoxy Resin, Part #s 125461 and 125229, from Fiberglass Coatings, Inc.), was laid directly on the second coat of epoxy putty. Then, three overlapping layers of fiberglass mat was laid, with an additional layer of mat laid at each of the end sections.
