Cabin Window Upgrade

Main Cabin Windows - Original Installation - Carmine Pizariello

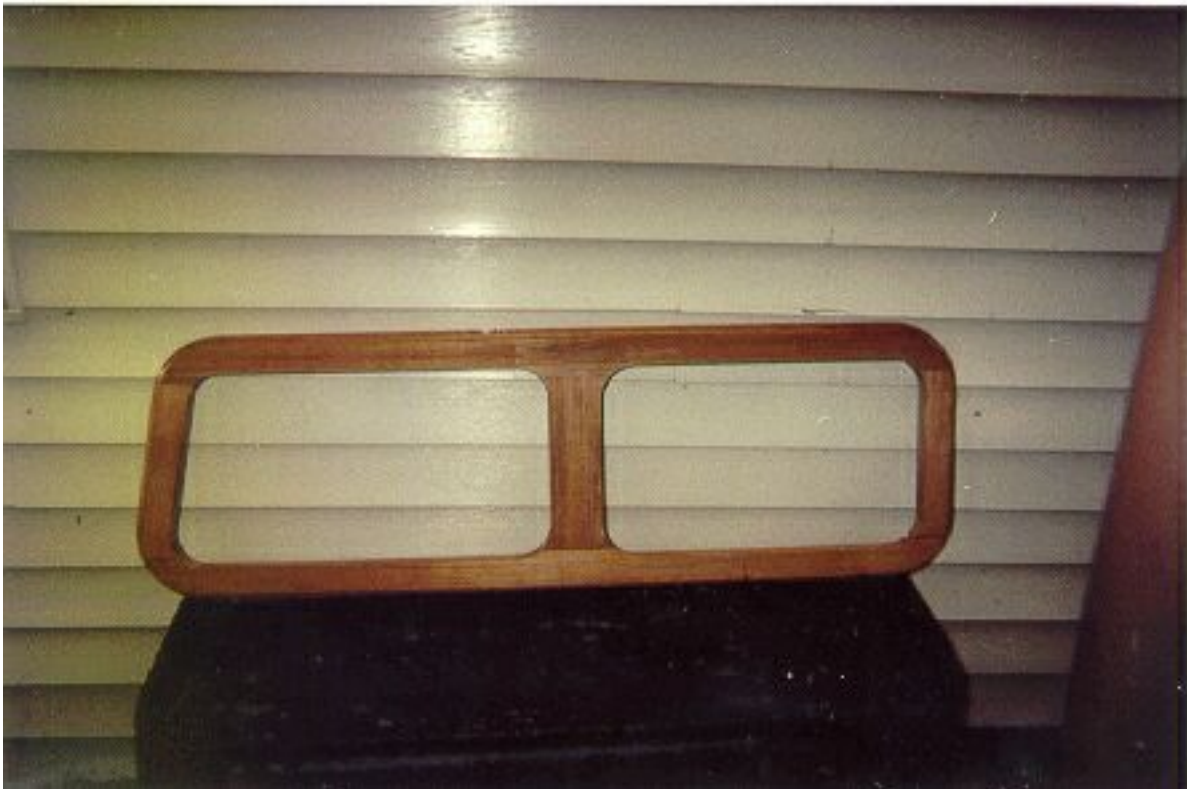
INSIDE VIEW OF FORWARD WINDOW FRAME

Window frames were fabricated from 1 3/4 " thick teak planks ripped into 2 1/2' inch strips. Each frame (4) was divided into two windows by a center mullion to add structural support and keep individual window size down. Windows were built square with mortis and tenon joints, and glued with West epoxy. The inside and outside curves were then cut using plywood templates, router and router guides. Curves, rabbits and edge rounding were expensive - all told I figure 30 to 40% of the teak was turned into sawdust.

Overall outer dimension of rear window frame was 42" X 14 1/2". Finished frames are 2' wide including rabbit for glazing. Corner radius on inside is 1 3/4', outside 3 3/4". Center mullion is 3 1/2" wide. Rabbit to accept Lexan glazing is 1/2" wide and slightly over 3/8" deep. Dimension of Lexan glazing for rectangular (6 of the 8) windows was 11 3/8' x 18 3/8". This allowed for 1/8" expansion all round. Two forward windows with elongated lower edge were in same proportion however size of the larger window was set so that the 6 smaller windows were all the same size.

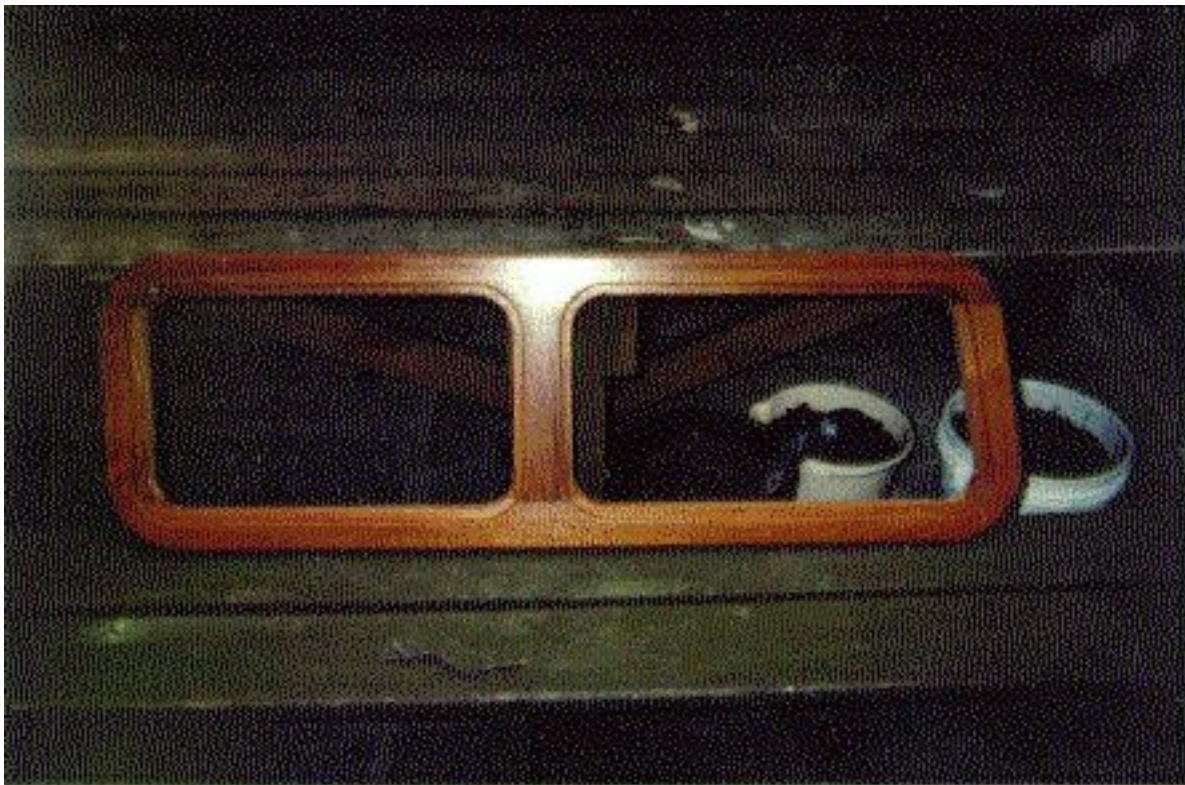
SAME FRAME, OUTSIDE VIEW WITH CETOL AND RABBIT FOR LEXAN GLAZING

The Lexan was cut with a router using a plywood template and router guides. This is remarkably tough stuff, I had to take 1/16th of an inch off at a time. Any more and I risked losing control of the router. Each Lexan pane was set in clear silicone using #6 SS wood screws on about 4" centers.

Outer edge of frame was cut with a 7/8" rabbit all round (thickness of the fiberglass cabin top). Then top and bottom edges were cut to match the curve of the cabin sides. A template of the curve in the cabin was used to cut each curve (i.e., 2 templates per frame, an upper and lower edge). The forward and aft ends of the windows kept the original 7/8" depth rabbit. Overall effect is that more frame is shown on the outside at the forward and after ends of the frame. See later photo.

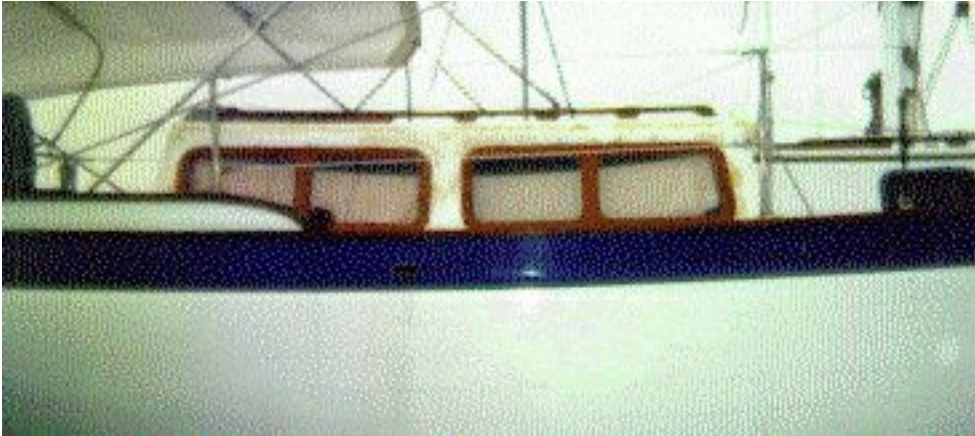
INSTALLED FRAMES

Each of the frames was set into to the cabin sides using the same combination of west epoxy and colloidal silica putty. I used a combination of clamps and wood screws to bring the windows home. The screws were set from the inside, countersunk and toed into the backside of the frame at the rabbit to pull the windows flush with the cabin sides. I used cut to size 2x2 with stand off and bar clamps to pull the windows in prior to using the screws.

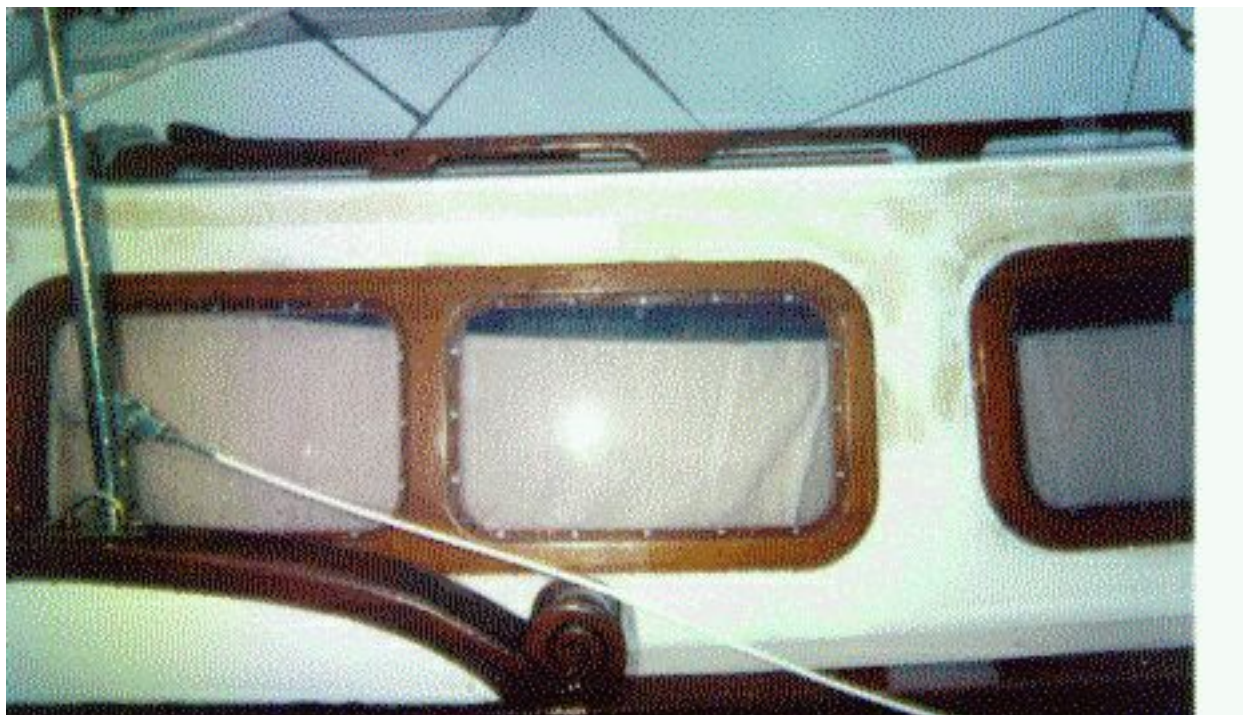
SAME FRAME, CLOSE-UP VIEW

Because I had cut the curve into the rabbit on the upper and lower edges of each frame, the windows required very little tension to bring them home since most of the curve had been taken into account. Clamping pressure was needed mostly to rack the frame since the curve between the upper and lower part of the frame was a compound one. I estimate the clamping force at less than 100 lbs. since I could bend the frames home with hand pressure alone.

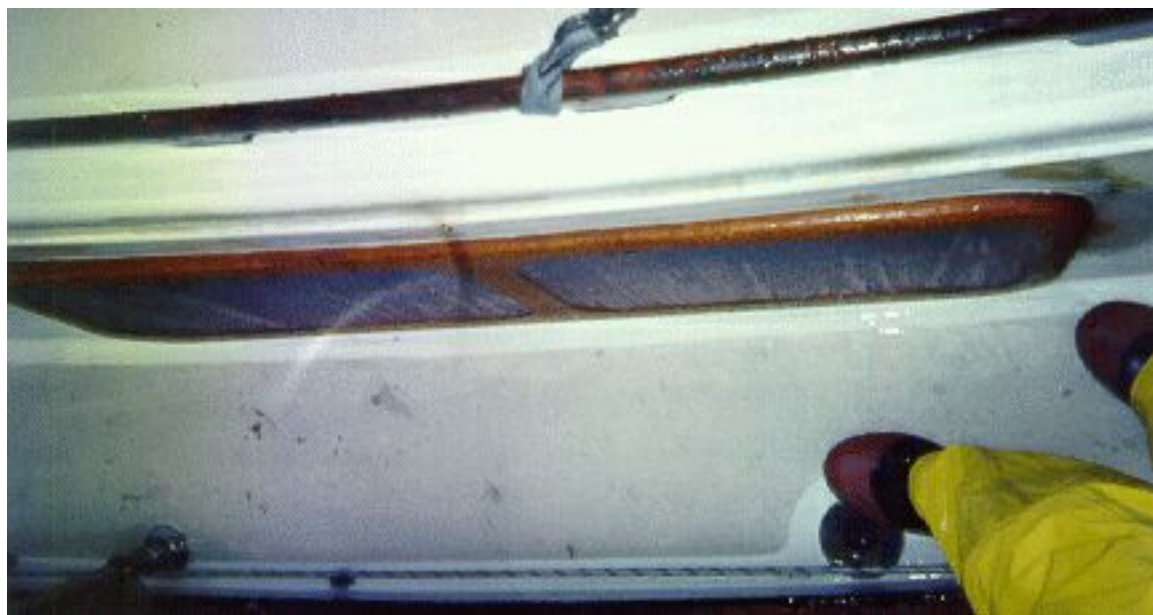
LOOKING DOWN - FRAME IS FLAT, RABBIT FITS THE CURVE OF THE CABIN SIDE

The overall effect on the inside of the boat is that the forward and aft edges of the windows are flush with the interior skin of the cabin sides. The center part of the window extends about $\frac{1}{2}$ " into the boat. On the exterior, the forward and aft ends of the window frame rise out about an inch from the cabin side skin. The center of the frame is about $\frac{3}{8}$ " from the cabin side skin.

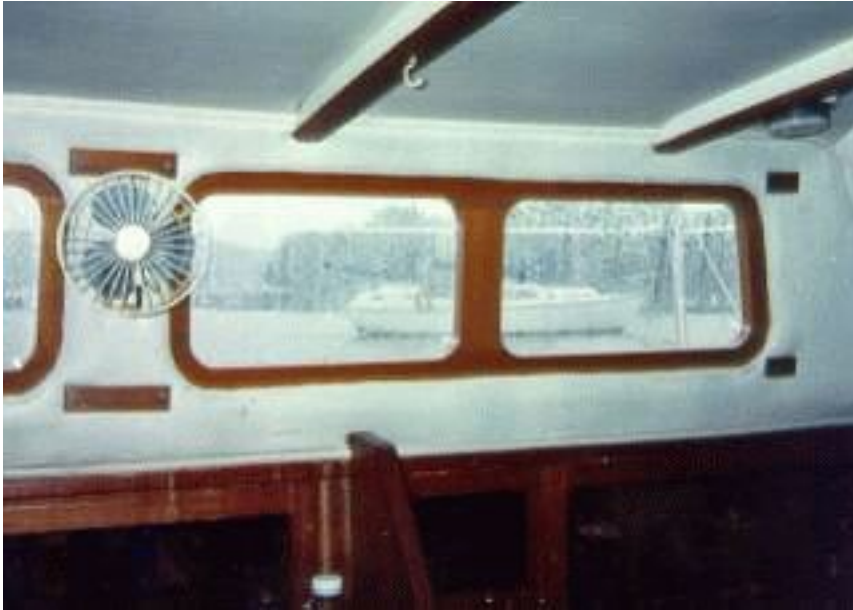
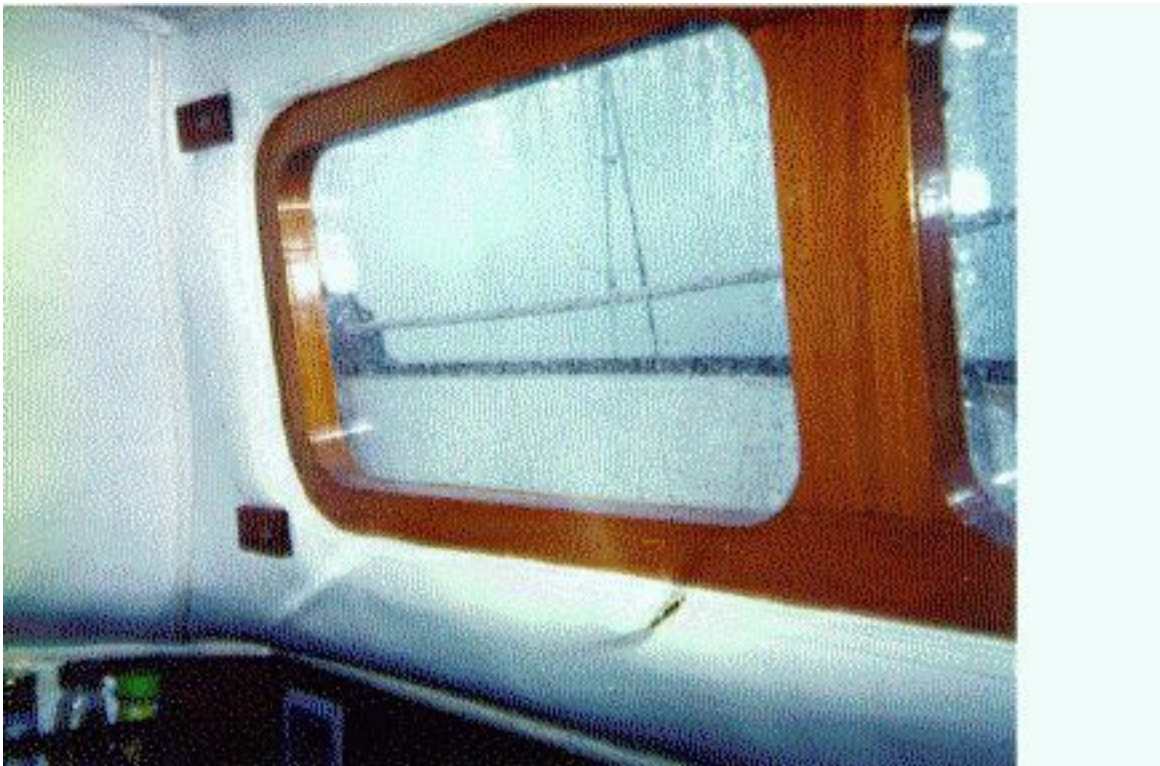
INTERIOR FINISH AND TRIM

A 3/8" plywood staple strip was screwed into the fiberglass around each window. The vinyl liner was then stapled to the strip using SS staples. Vinyl piping was then used to finish and hide the staples.
