Project: New Exhaust Elbow on DE45 Eolian

This project was submitted by Bob Salnick of DE45 Eolian
This project is from the winter of 2004/2005

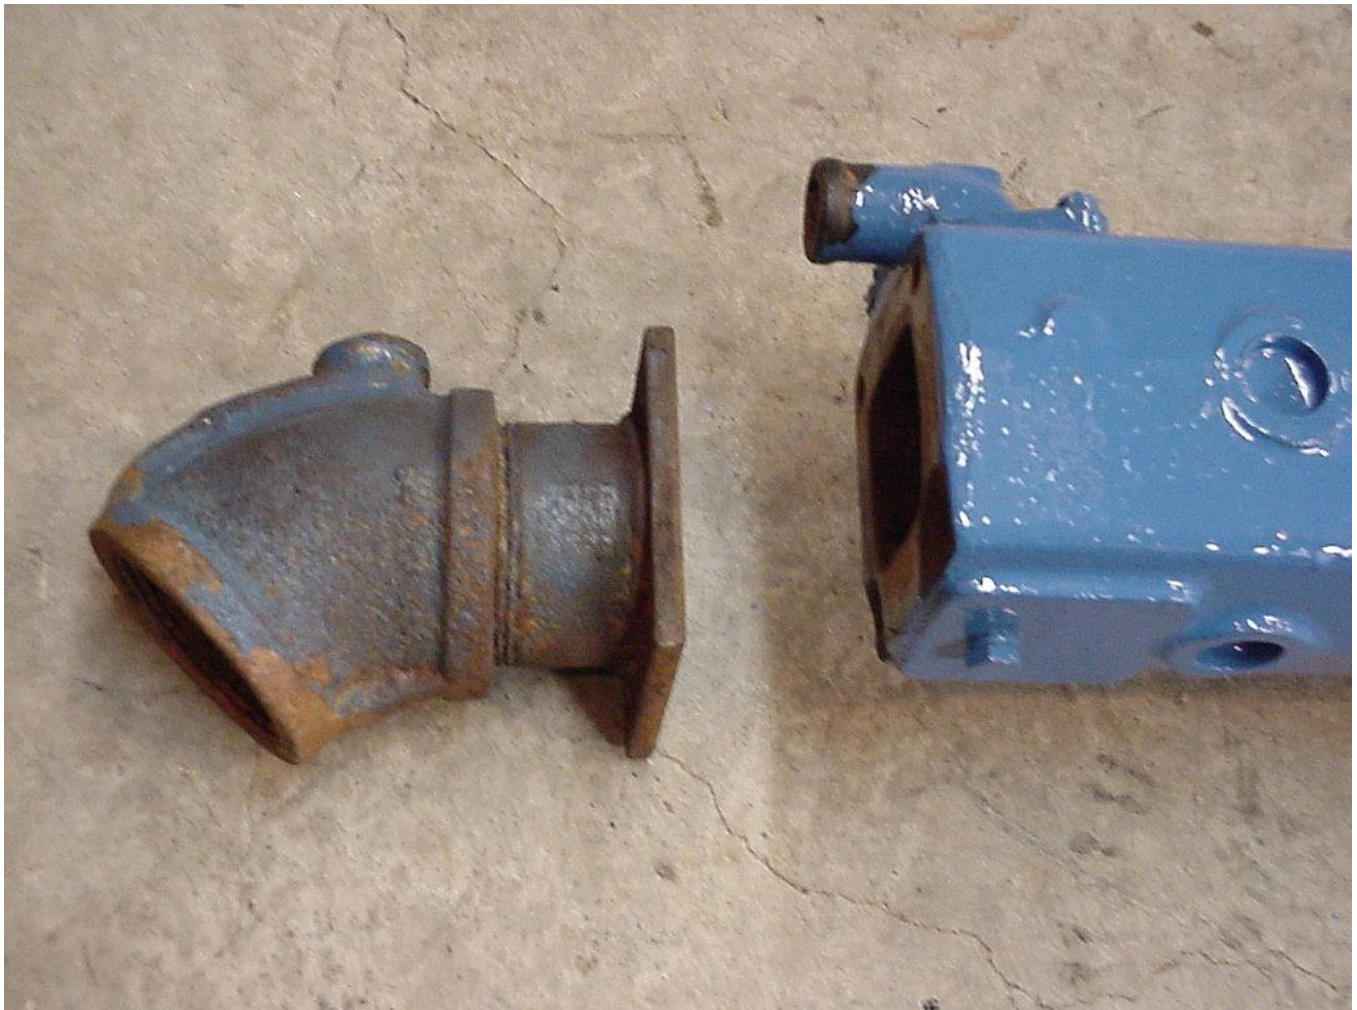
First, a brief lesson on marine engines... ours is 'fresh water cooled'. That means that it is exactly like a car engine. Except that instead of an air-cooled radiator, we have a heat exchanger which is cooled with sea water. The engine coolant and the sea water do not mix, any more than the air and the engine coolant in a car mix - they are separated by the internal walls of the water-air heat exchanger (radiator) or water-water heat exchanger (marine engine). Once the sea water has picked up the waste heat from the engine, it is put to one final use: It is dumped into the exhaust gases to cool them so that high temperature plumbing is not required for the exhaust system. It exits with them. The injection point is at an elbow on the very end of the (water cooled) exhaust manifold.

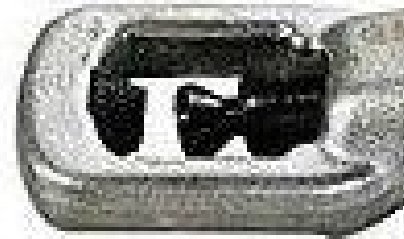
The studs were corroded to about 1/2 their original diameter - no wonder the first one twisted off. I applied heat with a torch, heating the studs to red heat and cooling them alternately, and finally they were removable from the manifold with a pair of vise grips - even the twisted off one. (Note to self: never use excessive force if you can get a nut buster on the nut...)

I used a nut buster to cut the remaining nuts off the mounting studs for the elbow and removed it.

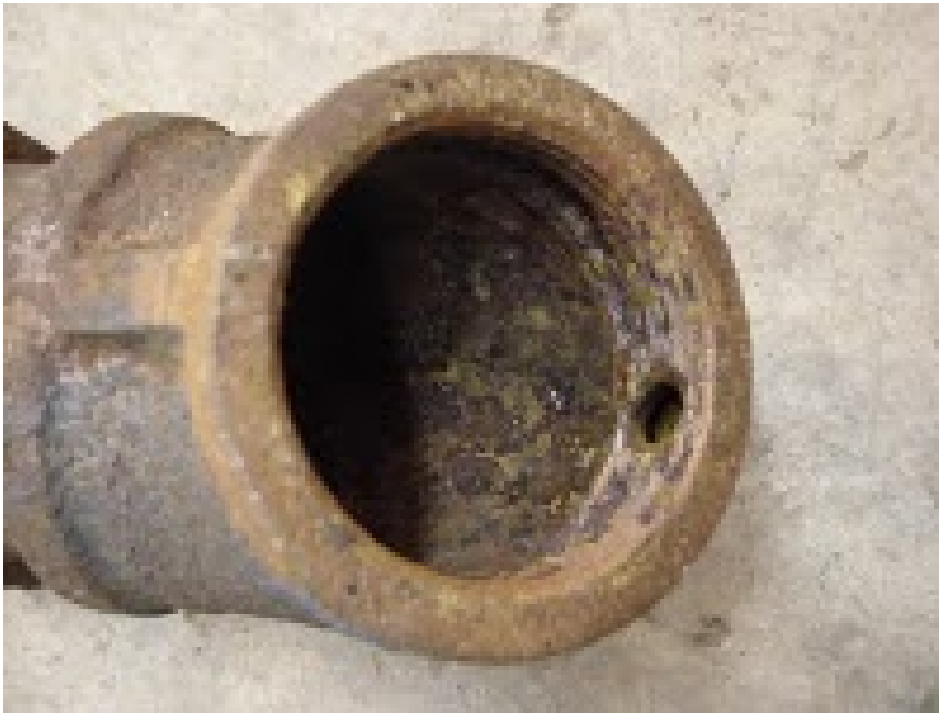
After cleaning, another defect was revealed. This exhaust elbow was constructed from a 2.5" 45 degree pipe elbow, on which an external channel had been welded (very nice job!). Finally, a hole was drilled into the external channel at the outlet end of the fitting to provide the water exit into the exhaust gas stream. In order to ensure that water exiting the hole would not find its way back to the exhaust manifold and the engine, the hole was drilled as close to the exit as possible (good!).

Unfortunately, it was drilled so close to the exit that it was in the threads, and when the outlet nipple was screwed in, it partly occluded the hole, undoubtedly spraying water back toward the engine (defeating the purpose of drilling near the exit - bad!).

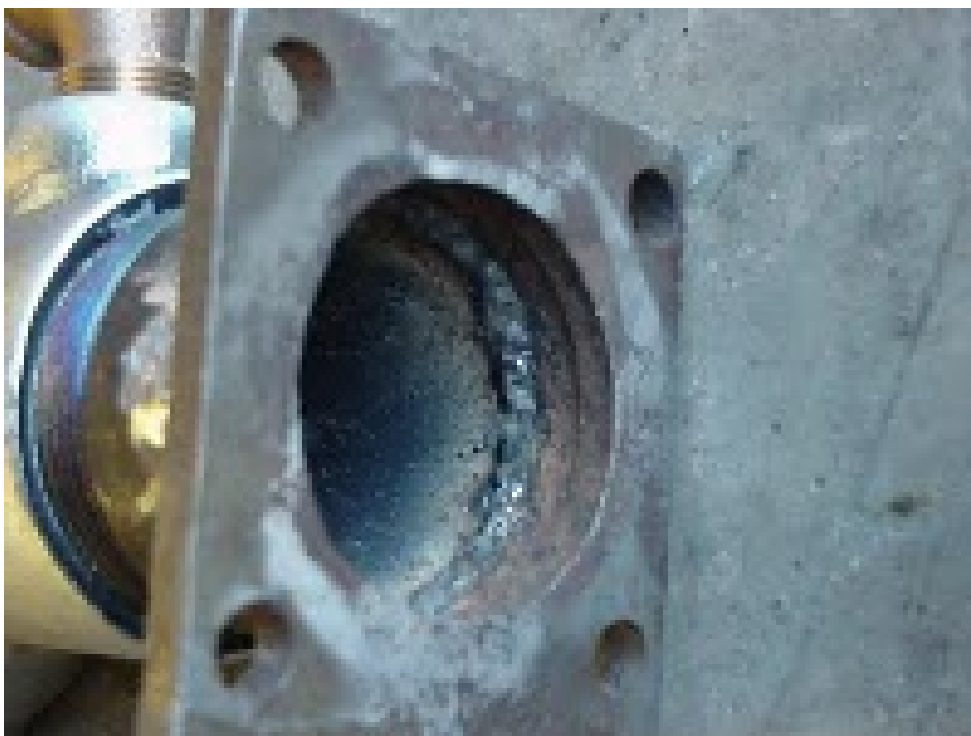
When I attempted to remove the flange end from the old elbow, the pipe broke off (corrosion again...). A repair was therefore necessary. Rather than weld directly on the flange plate (which would cause warping, and thus poor gasket contact), I cut off all but about 3/8" of the old pipe. Then I bought a 2.5" pipe nipple, and cut off an appropriate-sized piece. I beveled the ends of both and mig-welded them together. Since the new fitting had a heavier wall thickness than the old (corrosion again?), there was a shoulder on the inside - I welded this too.

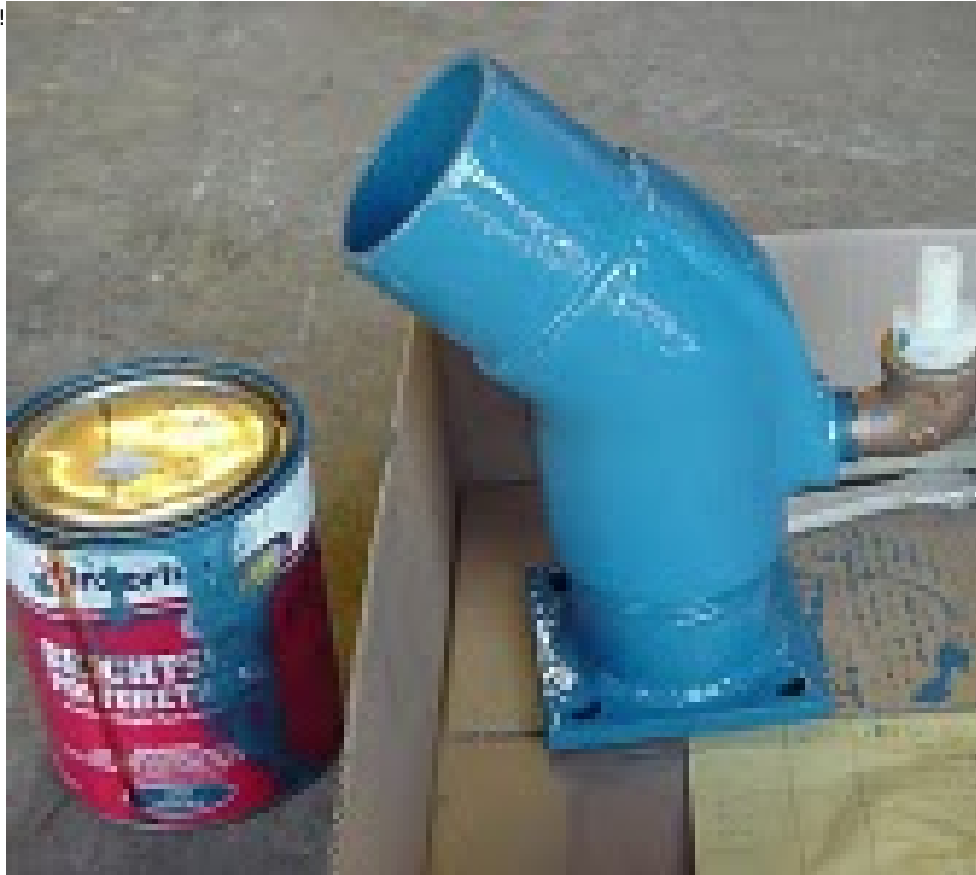
After grinding and painting, it looks really nice!

Reinstalling the exhaust manifold was easy, but then attaching the exhaust hose to elbow was really tough. I installed new studs in the exhaust manifold. Then I cut off about 3/4" of the old exhaust hose because the new elbow assembly is a little longer than the old one - tough job! This is heavy hose (1/4" wall thickness), with two, very hard, spiral steel wires inside. Then I coated the inside of the hose with silicone and inserted the elbow. Wow - that makes it sound easy! Actually I fought it for the better part of a half hour, grunting, groaning and bruising myself trying to get the elbow far enough into the hose. Finally, with more grunting and bruising, I had the flange over the new exhaust manifold studs and the whole works tightened down.
