Fuel Tank Replacement

Jason Rose of Bohdran a DE32 has also had to deal with this issue. Here is the information I was able to salvage of the internet archive.

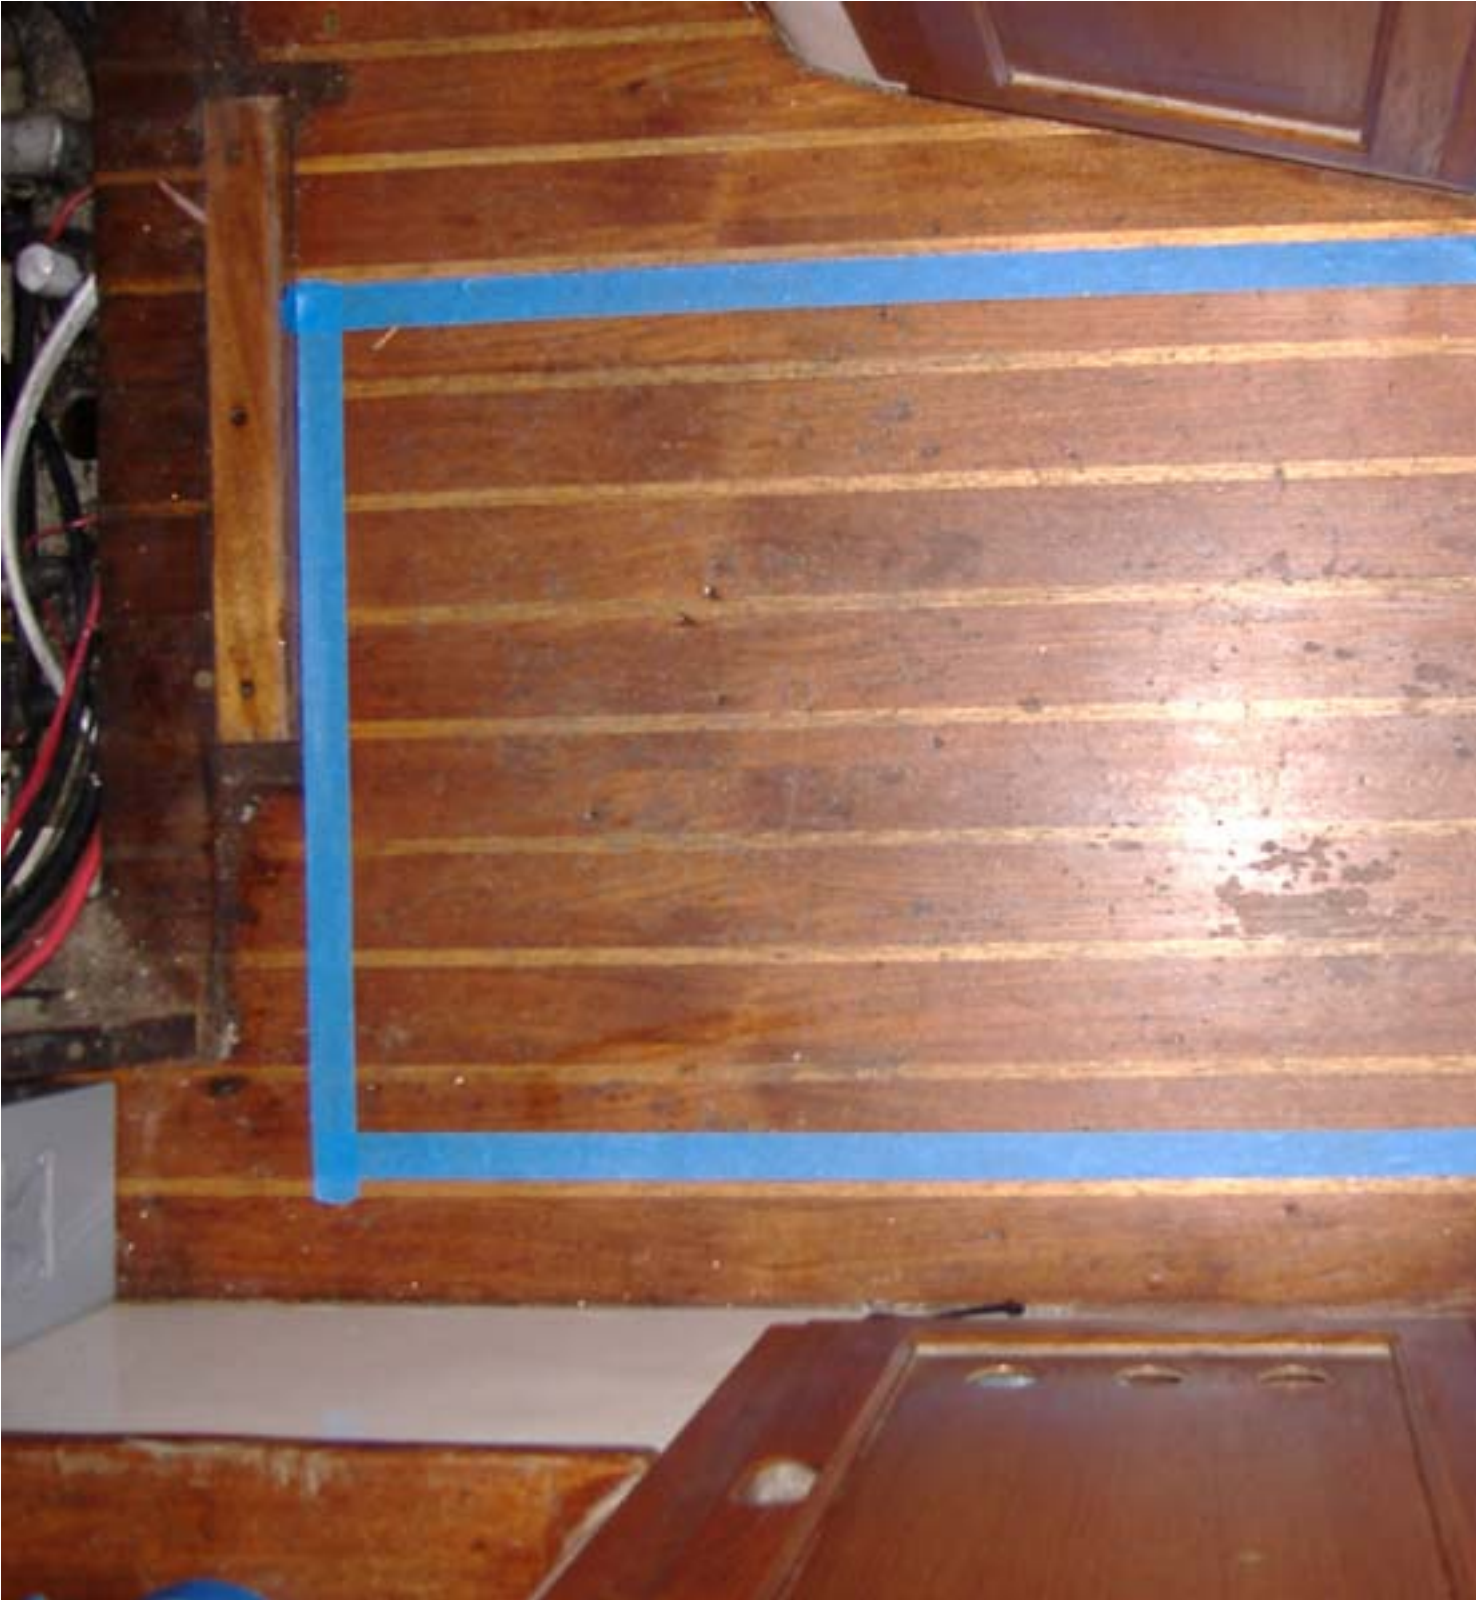
The first step in repairing the tank was cutting access into the top of the tank. I used a Fein Multimaster with with a piece of masking tape 3/4" up on the blade to mark the depth of the teak and holly plywood sole. Instead of drawing on the floor, I used masking tape to mark off the dimensions of my new access hatch. This way when I'm done I can use the cutout for the hatch.

[caption id="attachment_583" align="alignnone" width="800" caption="Figure 1. Masked and ready to cut."]

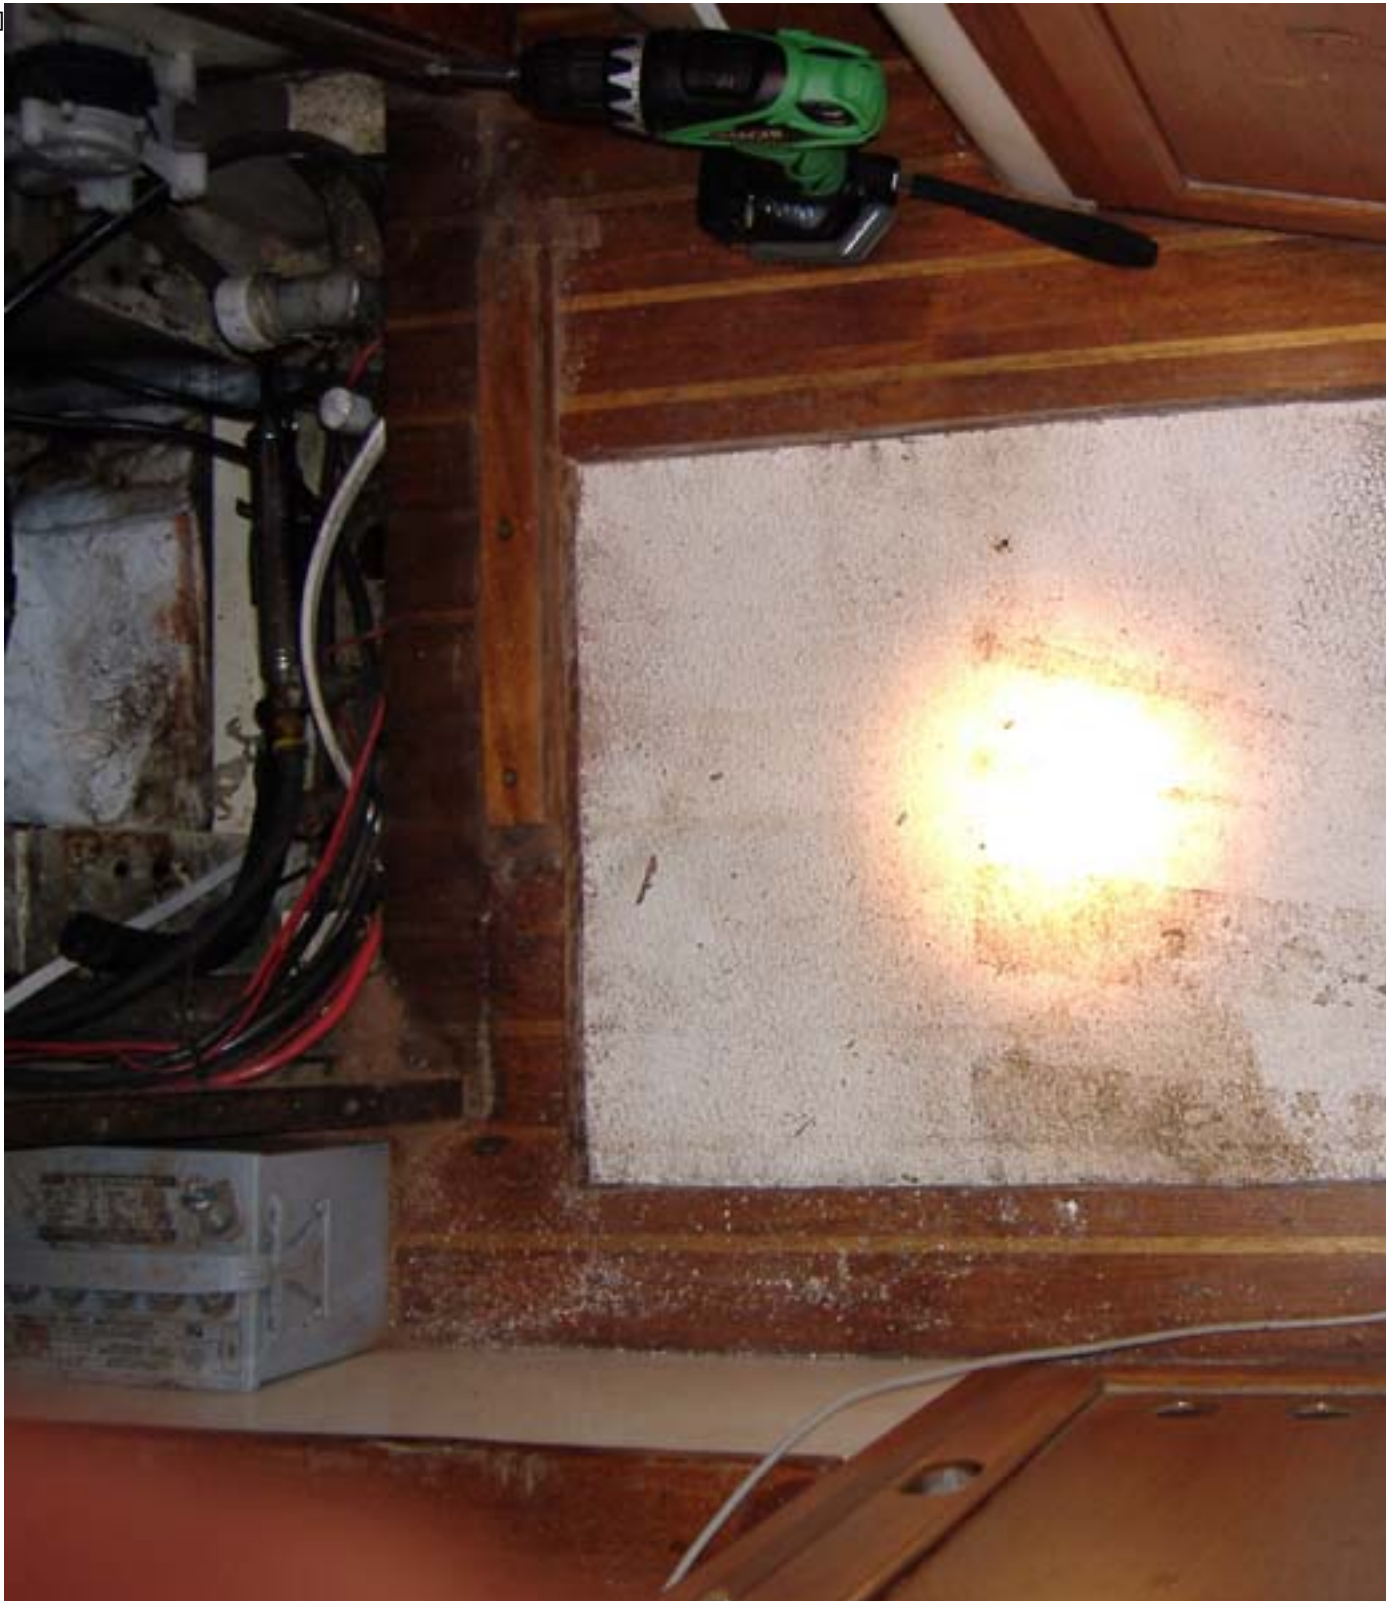
The first cut is only through the wood sole and not the fiberglass liner.

[caption id="attachment_584" align="alignnone" width="800" caption="Figure 2. Fiberglass hull liner revealed after wood is cut out"]

Then I cut through the hull liner leaving a 2" rim around the opening to act as a base for the hatch. I assumed that there would be baffles both fore to aft and port to starboard so I cut another access hatch in the galley floor and removed the drawers from under the galley counter to be able to access the port side of the tank. It turns out that there is only one baffle running port to starboard, so only the cutout at the base of the companionway is needed. I glassed back in the cutout in the galley to try and return some of the lost structure from cutting through the hull liner.

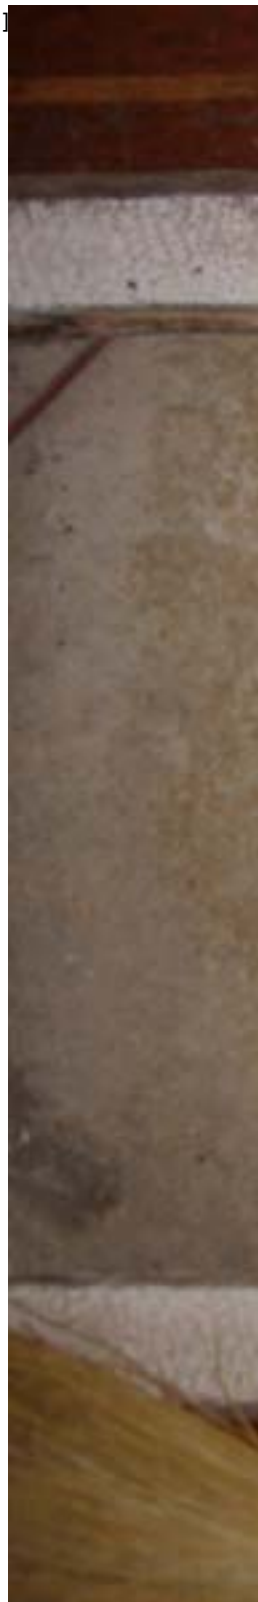
I located the baffle in the tank by thumping the top of it and installed inspection ports on either side of the baffle. I used Seabuilt (www.seabuilt.com) 10" aluminum inspection ports for diesel tanks. The ports were a bit pricey but were a breeze to install. The packaging for the ports is used as a template.

[caption id="attachment_586" align="alignnone" width="800" caption="Figure 4. Using template to align holes."]

All the holes lined up on the first try.

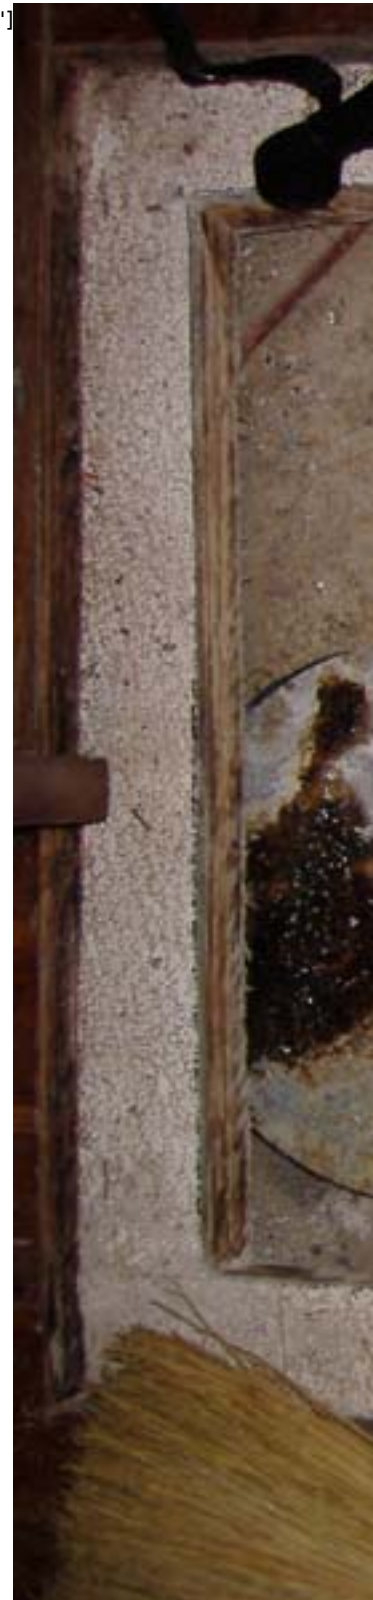
[caption id="attachment_587" align="alignnone" width="800" caption="Figure 5. Completed opening"]

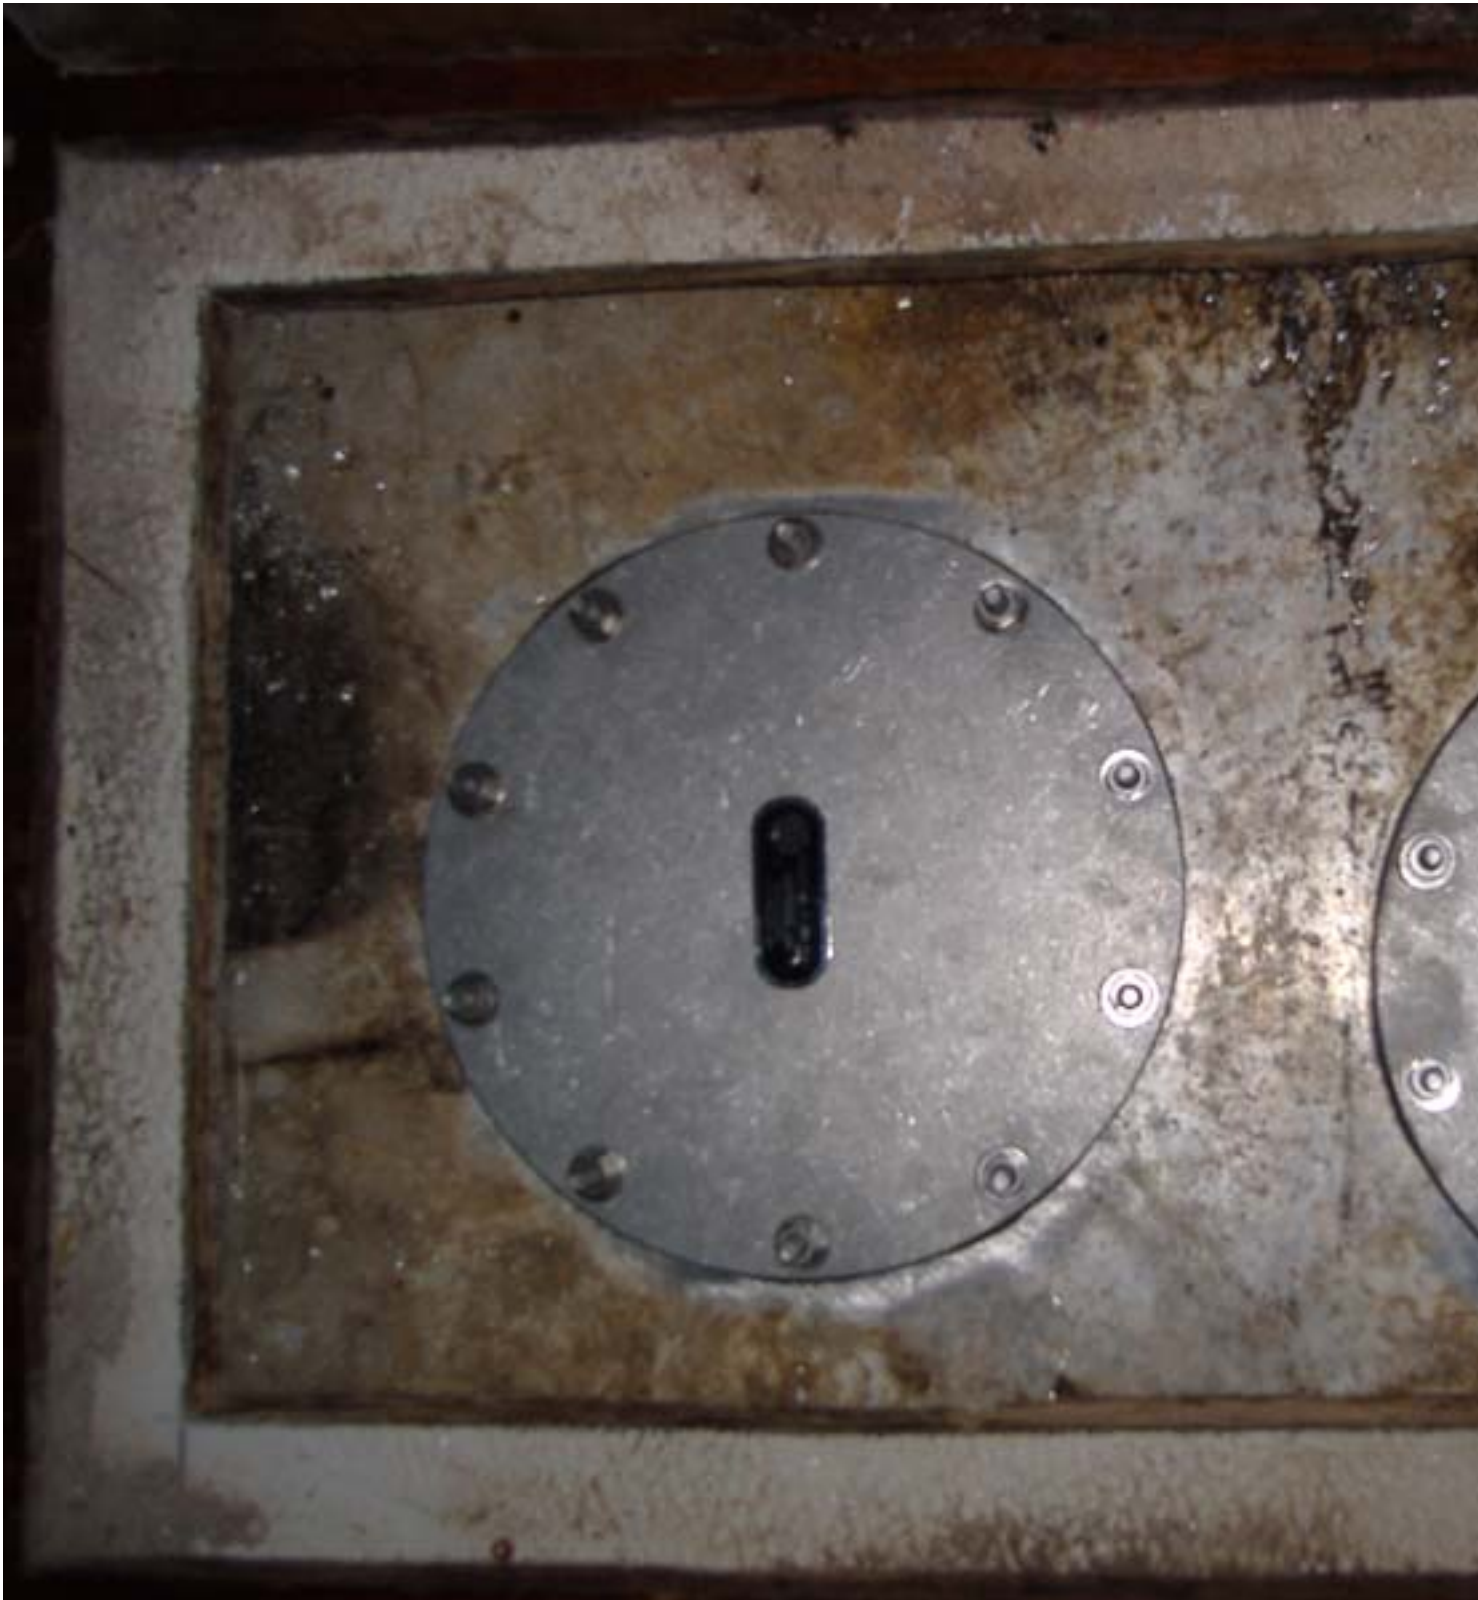
Once inside, I found that the draw line was clogged and there was good layer of sludge at the bottom of the tank. The draw

line on these tanks comes in at the aft end, runs down to the vee bottom and ends at the foreword end of the tank.

[caption id="attachment_589" align="alignnone" width="800" caption="Figure 7. Inspection holes on either side of internal baffle. "]

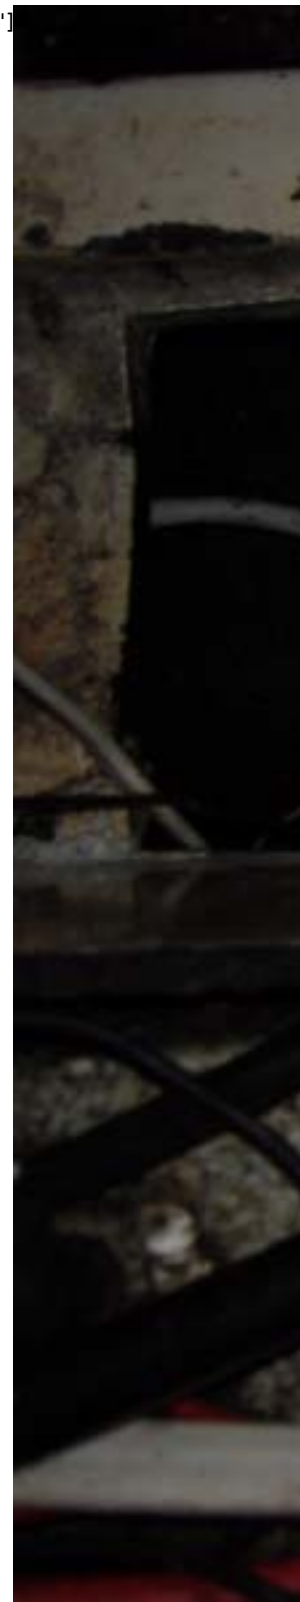
I thought that it was possible that the tank was capped just because the draw line was clogged, so I decided to pressure test the tank. I attached a bicycle pump valve and dial pressure gauge to the fill line. I used a bicycle pump to blow out the fill line and then sealed off the inspection ports, the vent, return and fill lines.

I pumped the tank up to 3psi to determine whether it was air tight or not. I could hear a leak somewhere from the aft end of the tank, so I "painted" all the fittings and as much of the tank I could get to with soapy water to see if I could find the leak. Unfortunately all the fittings were air tight, and I couldn't find where the tank was leaking.

[caption id="attachment_590" align="alignnone" width="800" caption="Figure 8. Pressure testing the tank. "]

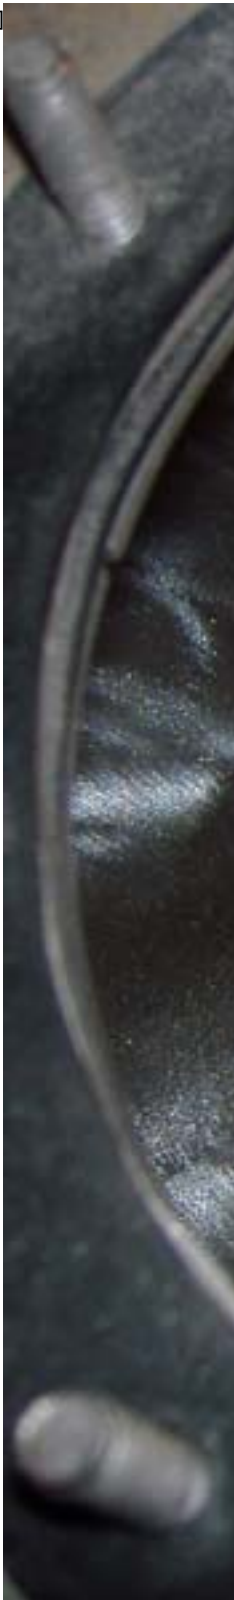
Next I wire brushed as much of the tank as I could reach using a 4.5" angle grinder and then a hand brush for all the corners. I then wiped down the inside of the tank with acetone.

[caption id="attachment_591" align="alignnone" width="800" caption="Figure 9. Cleaned up and ready to paint. "]

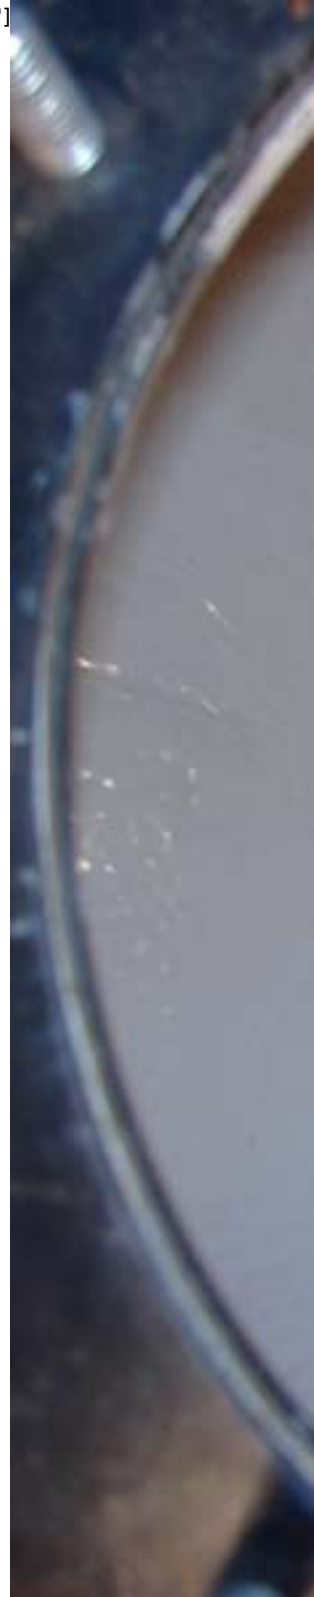
[caption id="attachment_592" align="alignnone" width="800" caption="Figure 10. Epoxy paint seals leak. "]

In order to seal the tank I decided to use Ameron Amerlock 2/400 high solids content epoxy paint. It was recommended to me by a company down in Seattle that specializes in fuel tanks. I cleaned out the tank as well as I could by hand. I painted the inside of the tank using a small extension handle and a foam brush. The Amerlock paint goes on thick, so only one coat was

necessary. I went back over all the welds and corners to ensure that they got an extra thick coat.
