DE 45 Holding Tank Replacement

By Bob Salnick

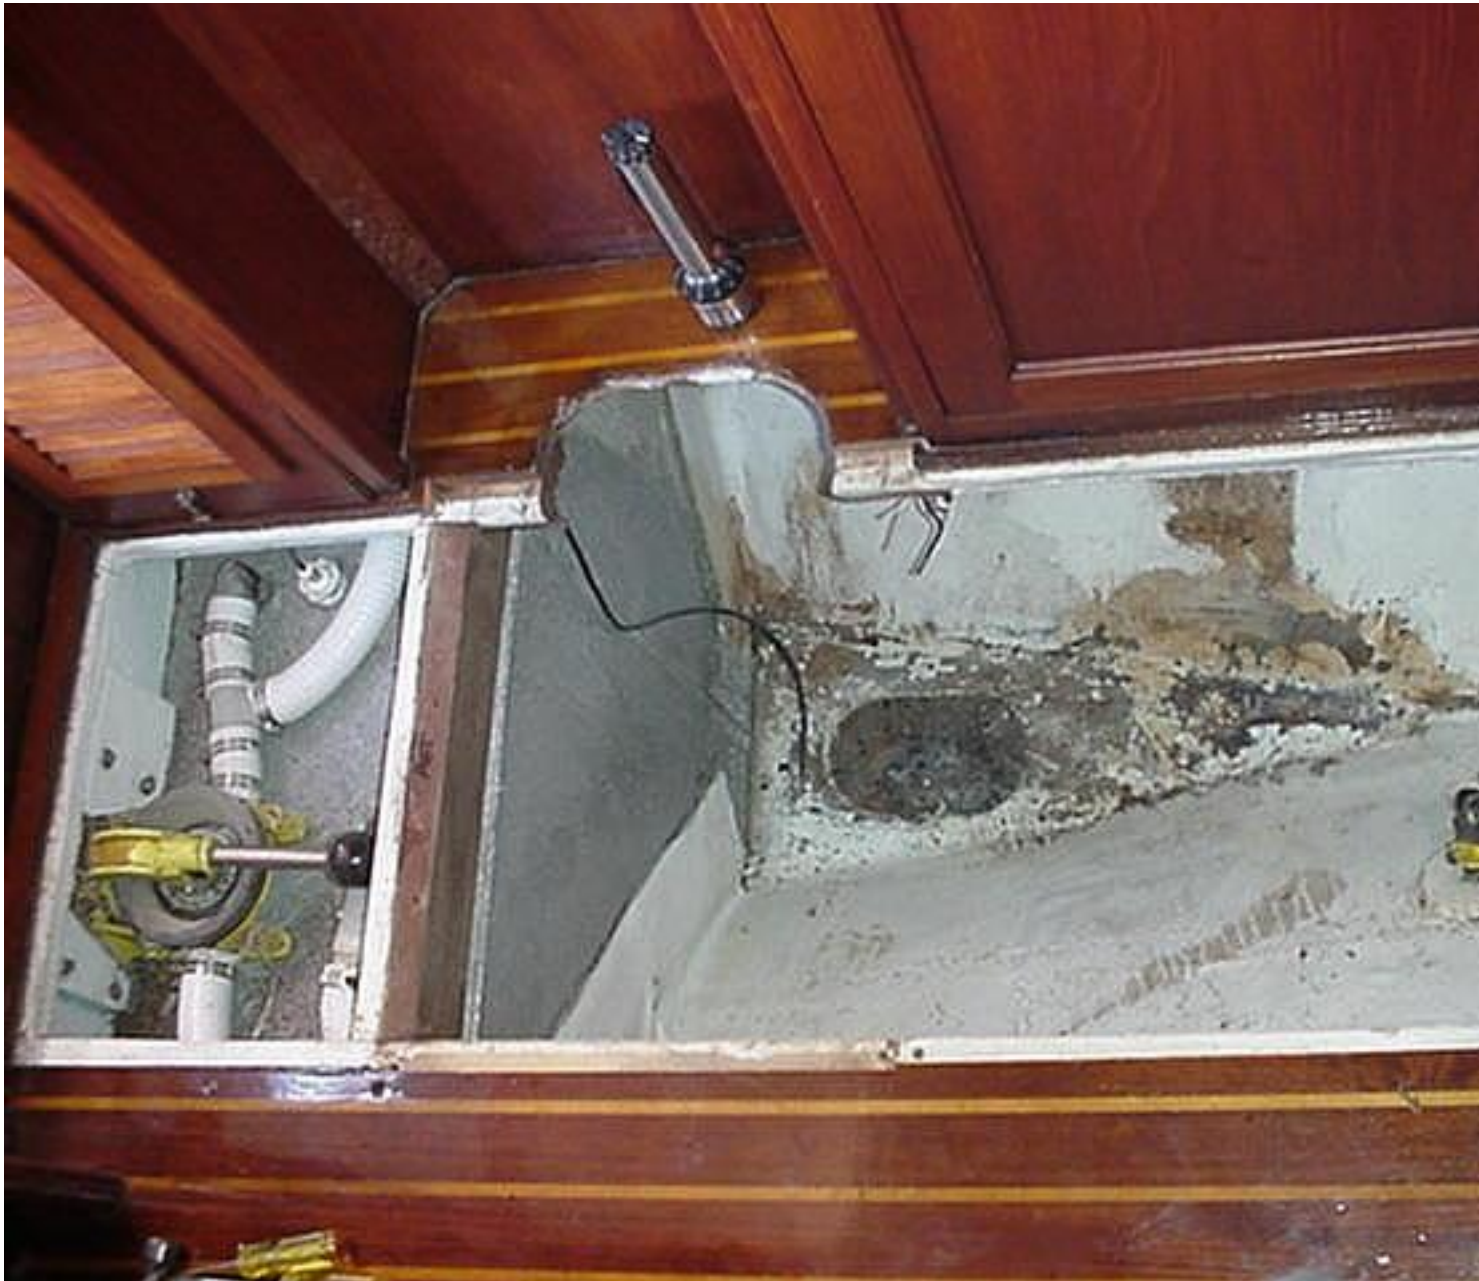
[caption id="attachment_640" align="alignnone" width="640" caption="pix#1"]

On the DE45, the holding tank is in a small bilge compartment amidship. It lays athwartship, just forward of the main bulkhead. There are two hatches into this compartment, but neither is very large. Initially, I carefully measured up the space and the hatches and sent the measurements to my son Adam, who put them into a CAD program. I then gave him a Ronco tank catalog which he then used to determine which tank(s) might be able to fit thru the hatch and be subsequently turned into place. As it turned out, only very small tanks (less than 20 gallons) could fit and be turned into position. So we bit the bullet and cut out the section of floor between the hatches and removed the supporting 4x4 teak beams underneath. (Pix #1 shows the situation when the aft beam was still in place. The existing holding tank is the silver tank in the left of the picture. You can also see the place on the bottom of the bilge where the mast step used to be.) Now the opening is large enough to accommodate a tank of realistic size: 45 gallons (the same as the existing tank).

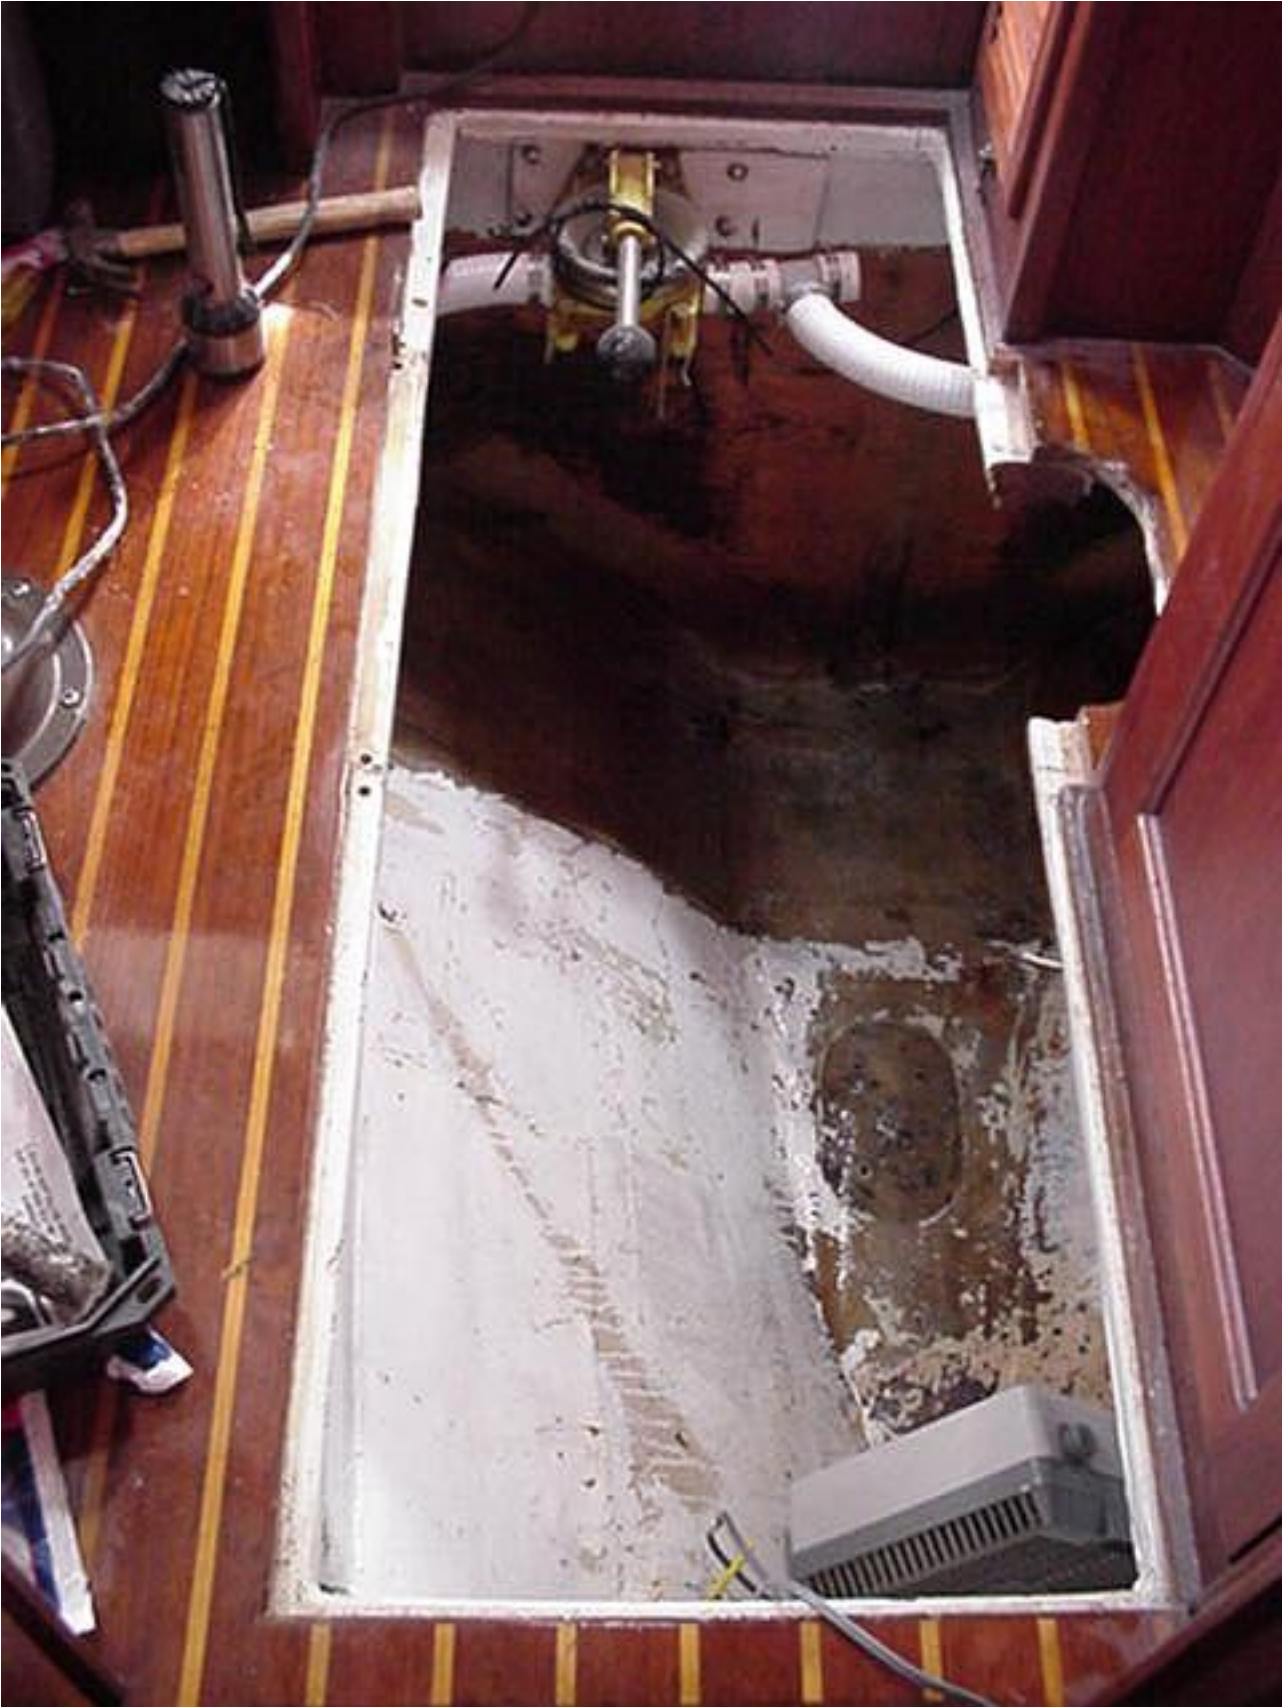
[caption id="attachment_641" align="alignnone" width="480" caption="PIX#2"]

There is a lot more room down there now...(pix #2).

Now mind you, there was only a little smell initially, but after the coating on the inside walls was disturbed, and after the 2" of sludge in the bottom started sloshing around, it was a totally disgusting job. After all the pieces were out, I sloshed bleach over everything and then scooped up the remainder into a bucket. Yes, there was a lot of misc. "stuff" around, behind and under the tank. Then hose out the area after the bleach swab-down. Then shower. Shower. Shower again.

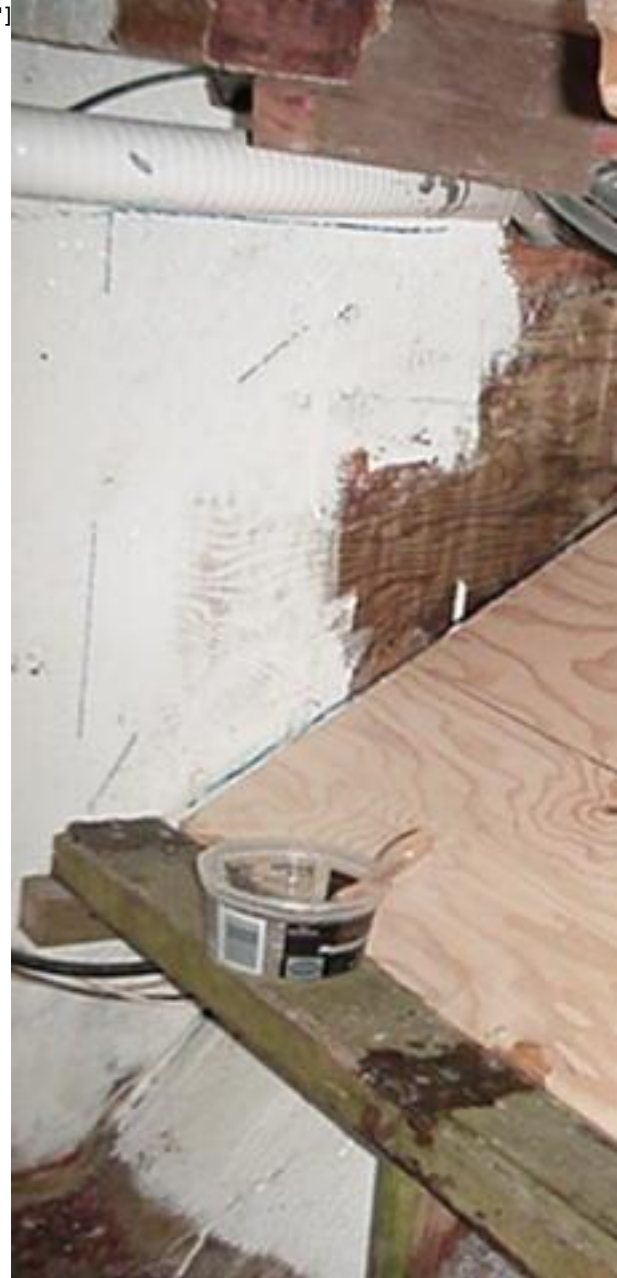
[caption id="attachment_642" align="alignnone" width="640" caption="PIX#3"]

The custom-manufactured tank arrived only a week after ordering! It is a rotationally molded polyethylene tank, with 3/8" wall thickness. The new tank goes on the port side of the compartment instead of the aft bulkhead. In order to keep the tank in place, a substantial framework had to be built and fiberglassed to the hull (pix #3). It was an interesting design problem fitting the framework as an interface between the regularly shaped tank and the tapered form of the hull. One should remember that when full, the tank will weigh over 400 lb, and will attempt to jump around down there in a seaway. A loose, full holding tank is a thought I really don't want to contemplate.

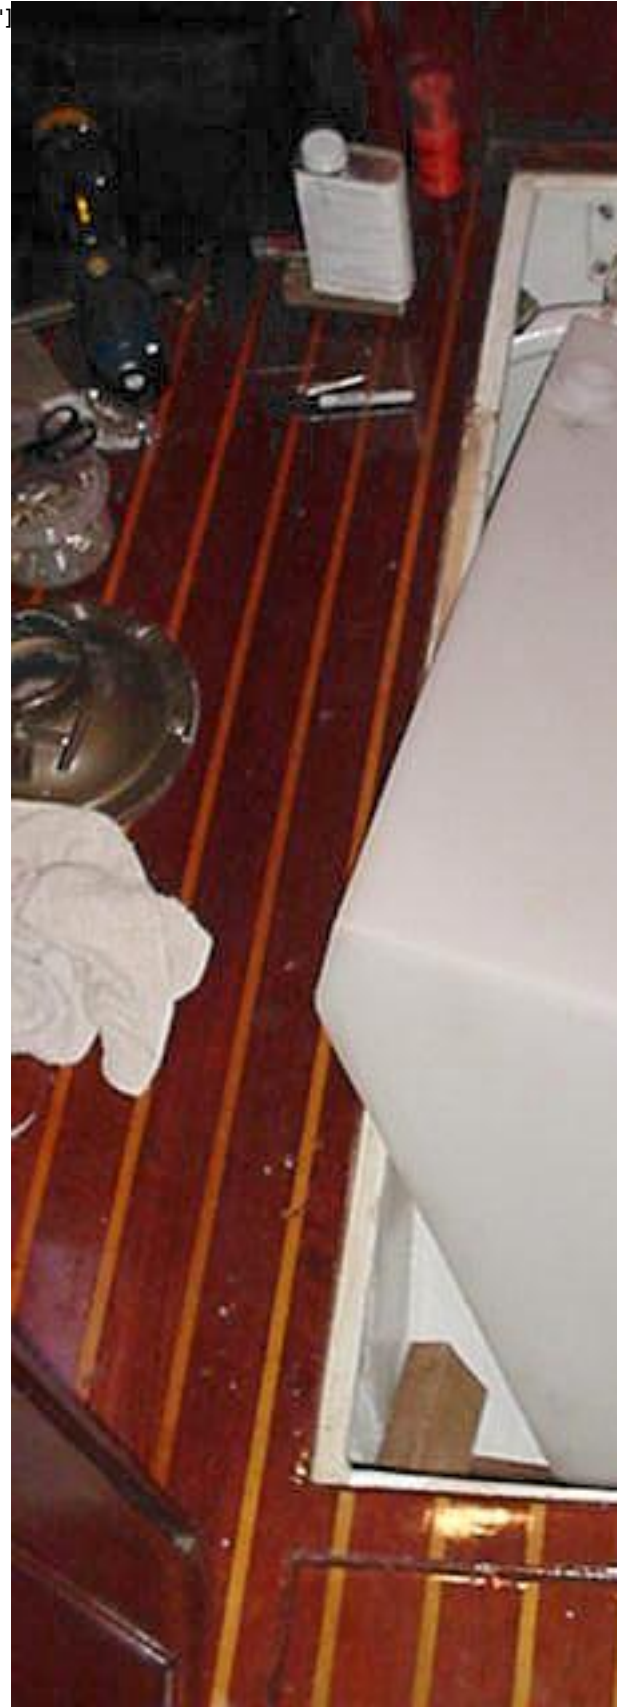
[caption id="attachment_643" align="alignnone" width="480" caption="PIX#4"]

As the construction proceeded, lots of trial fittings were required, each a fairly major ordeal (pix #4). For the final fitting, the plumbing was attached (pix #5 - it couldn't be done when the tank was in place), and the tank was installed. For completion, 2x4 keepers were screwed in place trapping the tank (pix #6). You can also see that we gave the entire bilge compartment a couple of coats of white paint, which improved appearances immensely (pix #7).

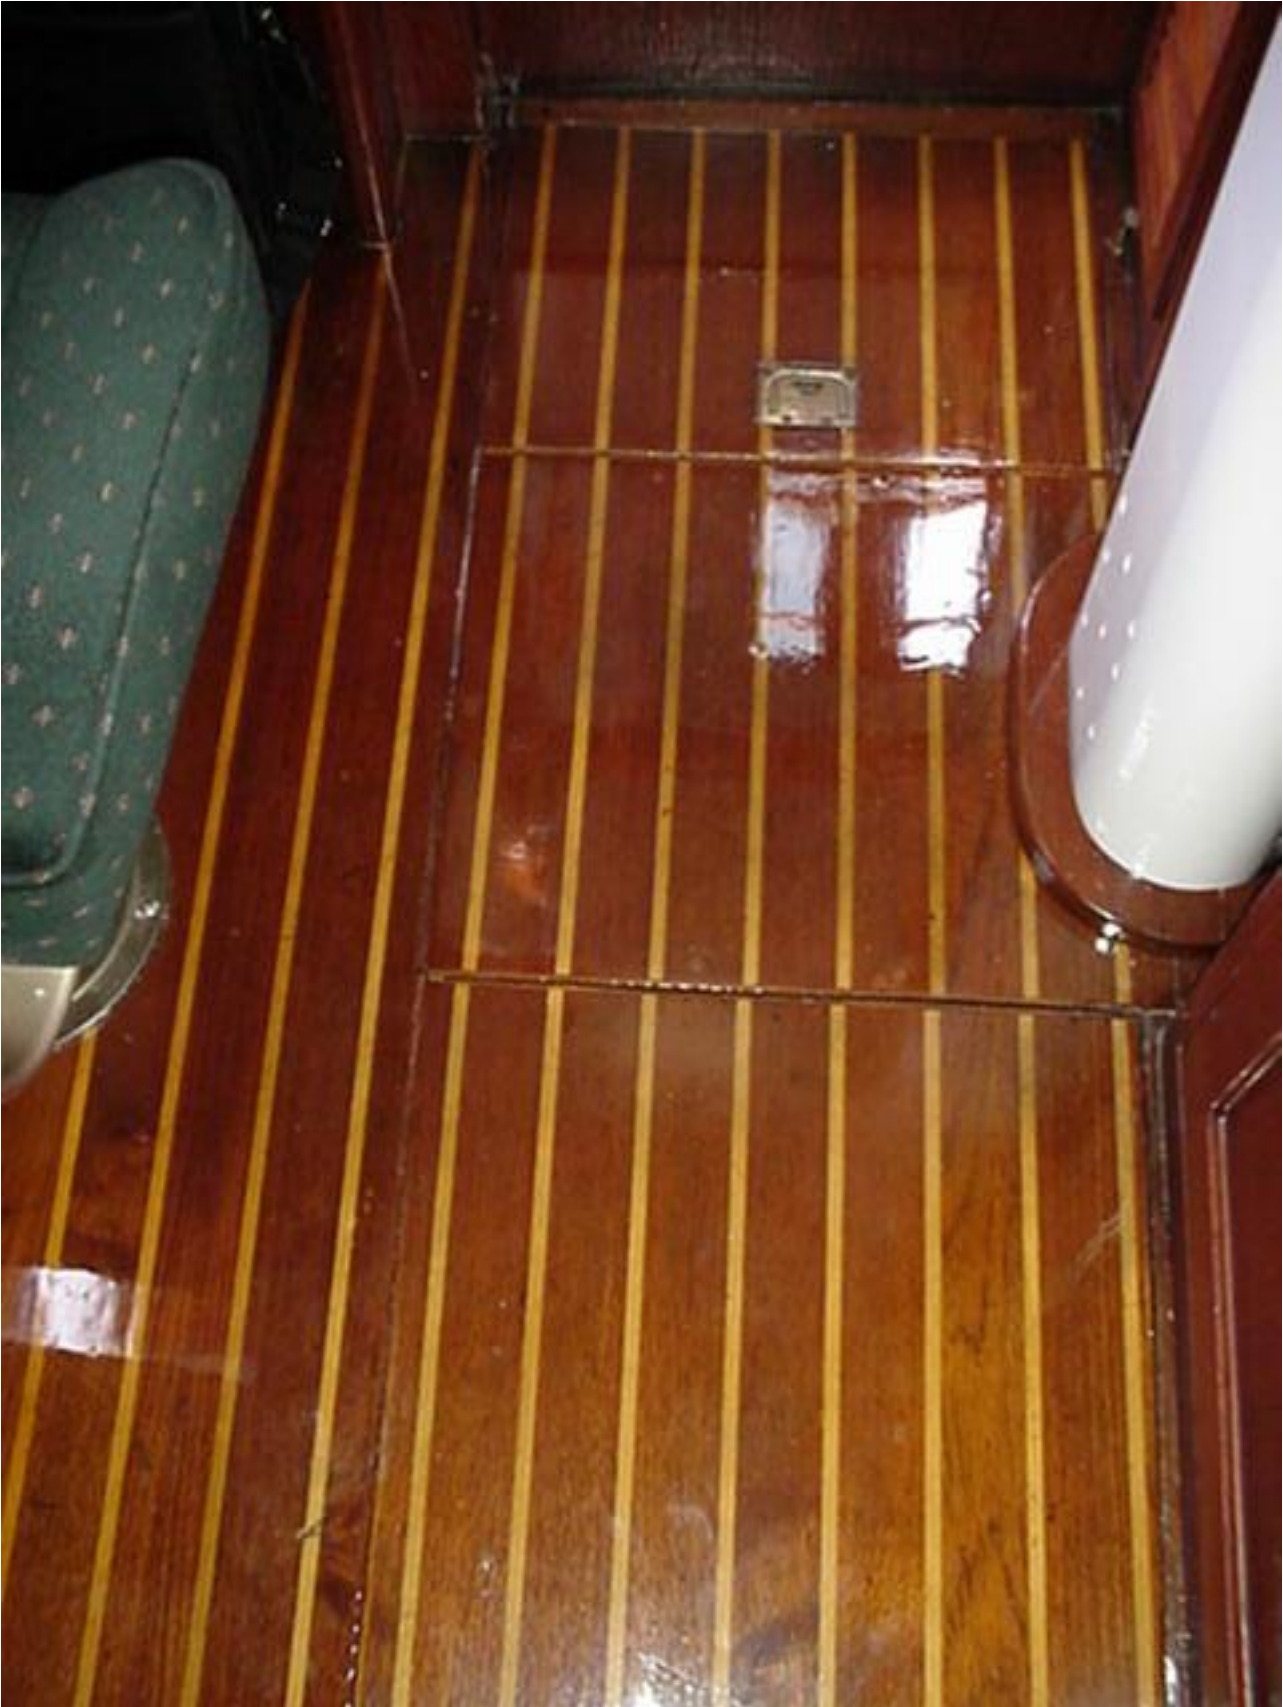
[caption id="attachment_647" align="alignnone" width="480" caption="PIX#8"]

Finally, the deck beams were replaced, and the floor panel was reinstalled. To make the seam where the saw cut was made look like a factory installation instead of a repair, thin teak strips were cut and used to edge the opening and the panel. Then the whole works was given several fresh coats of varnish (pix #8).
