DE 45 Window Replacement

By Bob Salnick

We have Doweast 45, hull #11, and like many Downeast owners were faced with deteriorating, poor quality unsafe large cabin windows. After years of procrastating (a lot) and research (a lot also), I contacted the Canadian company Bomon www.bomon.com made the contact only after getting a healthy endorsement from Tavarua (bigwave@emeraldoe.com), who has already made the purchase (but not yet the installation) of large windows for his boat. It was an initial report by Tavarua on the DowneastYachts web site that served as the starting point in the project for us.

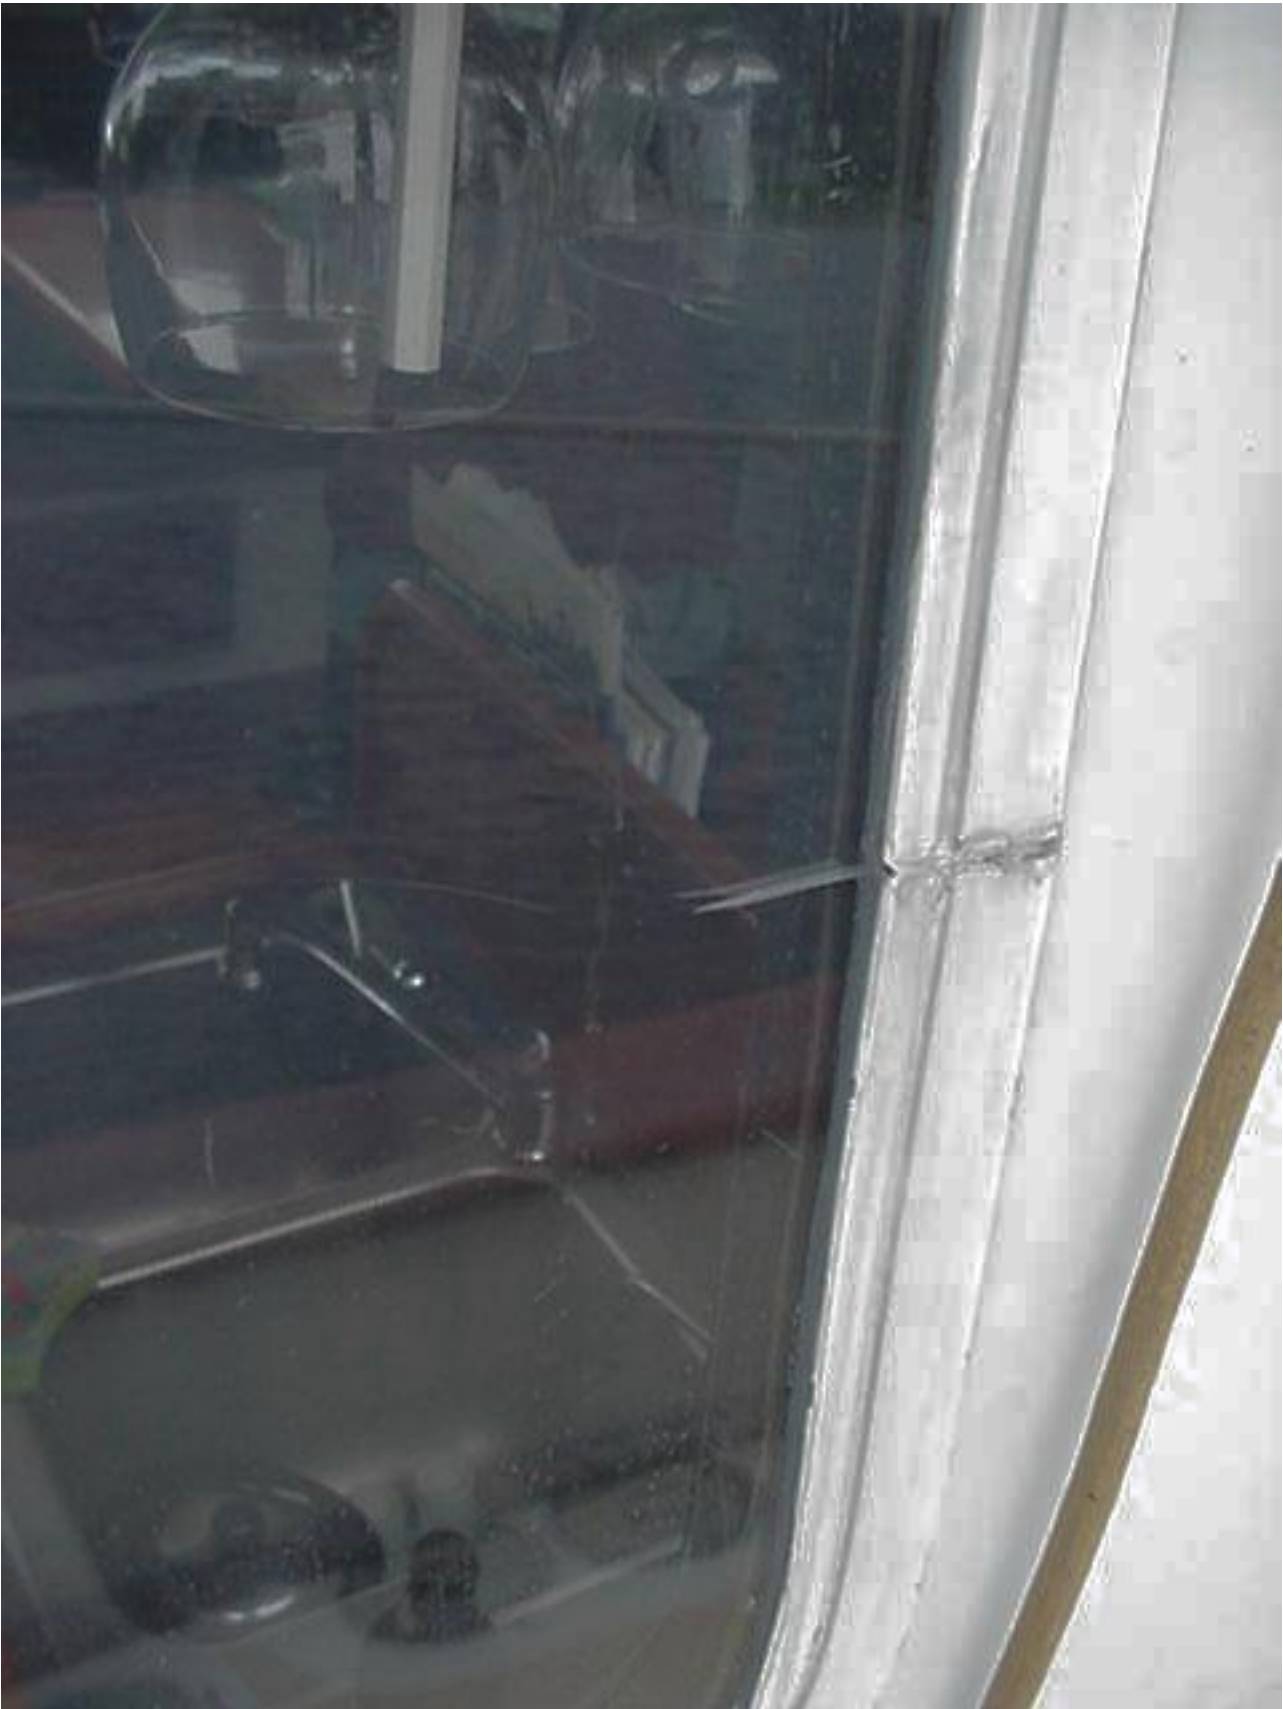
[caption id="attachment_628" align="alignnone" width="480" caption="PIX#1"]

One summer day, we removed all 6 of the large cabin windows - not a very tough job. As other Downeast owners will recognize, these were of low quality when installed, and haven't improved over the years. The rim extrusions were of too light for the duty - when the attempt was made to curve the windows to match the cabin sides, the extrusions simply rolled. The glazing was the standard homeowner's size of 1/10", which is way too thin for marine service, especially in such large panels (18" x 36"). The rim extrusion groove to hold the glazing was no more than 1/4" deep, perhaps less. The "rubber" which was used to seal the glazing in the extrusion channel had gone hard, and no longer served its purpose - water came in between the glazing and the extrusion. Given the thin section of the glazing and the vanishingly small groove, it would have been possible to push the glazing out of the frame, were the boat to fall off a wave. Finally, the glazing had cracked at most of the rim extrusion joints

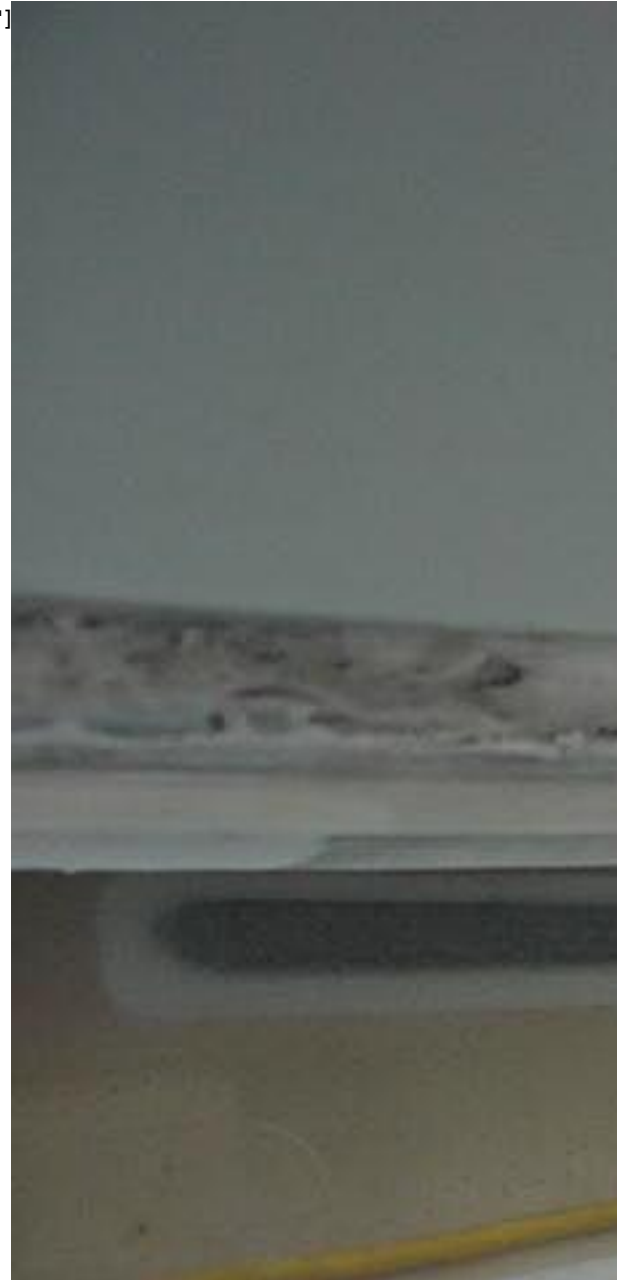
[caption id="attachment_629" align="alignnone" width="640" caption="PIX#2"]

Because the extrusions had rolled rather than bent, the seal between the windows and the cabin sides has been held over the years with an ugly accumulation of silicon rubber. It was time for them to go.

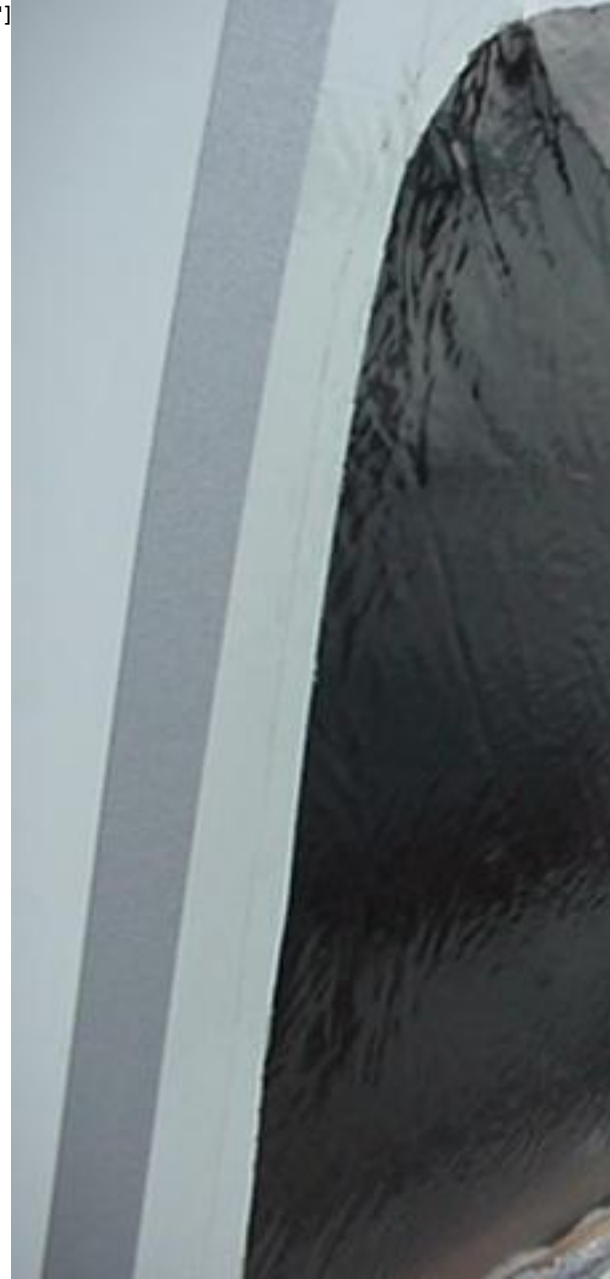
[caption id="attachment_631" align="alignnone" width="640" caption="PIX# 4"]

After the windows were removed, the openings were carefully measured using an aluminum straightedge, and the specs were sent to Bomon. Then the openings were covered with vinyl (really kind of translucent... we've lost our view pix #4), held on with long-term masking tape.

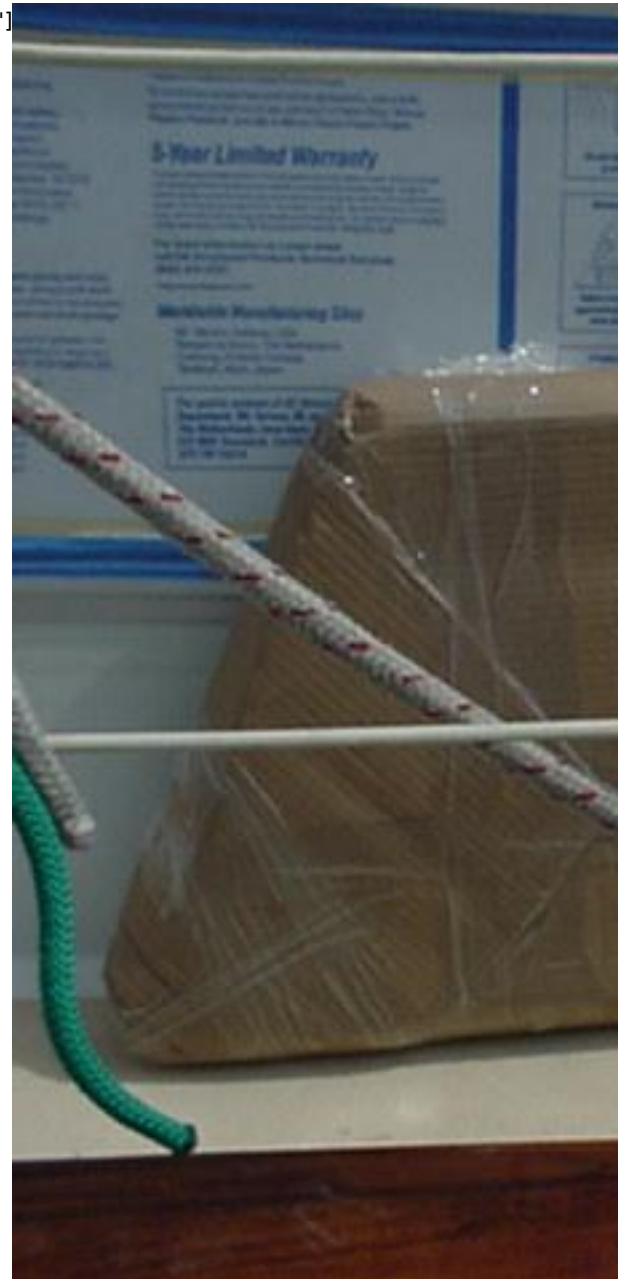
[caption id="attachment_632" align="alignnone" width="640" caption="PIX#5"]

Bomon delivered on time (really!). The windows were shipped in a large box with lots of padding, and each was individually wrapped with heavy polyethylene and a padded overwrap (pix 5,6).

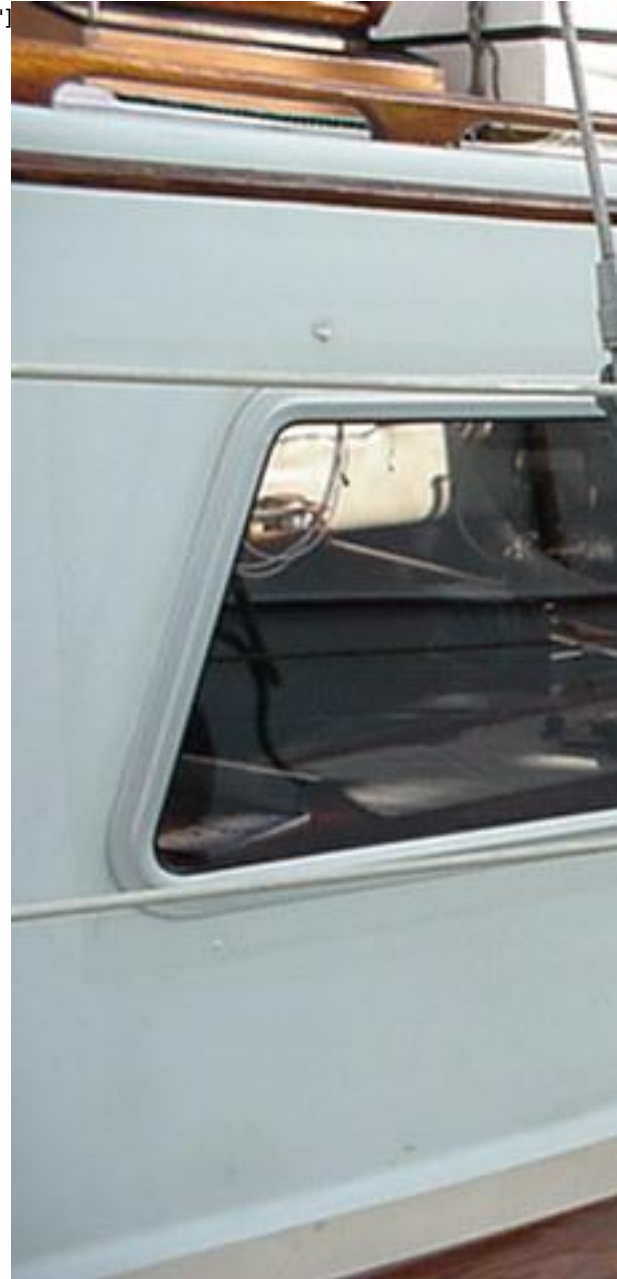
[caption id="attachment_635" align="alignnone" width="640" caption="PIX#8"]

Well, they're in - it took a couple of afternoons. These windows are ***SOLID***. And they look GREAT (pix 8). And the anodized frames are much more attractive on the inside than the old dark brown ones were (pix 9). We could not be more pleased with the process and the results. I cannot recommend Bomon highly enough, and Alain in particular.
