Cutlass Bearing Replacement

Changing out a Cutlass bearing on a DE38 -

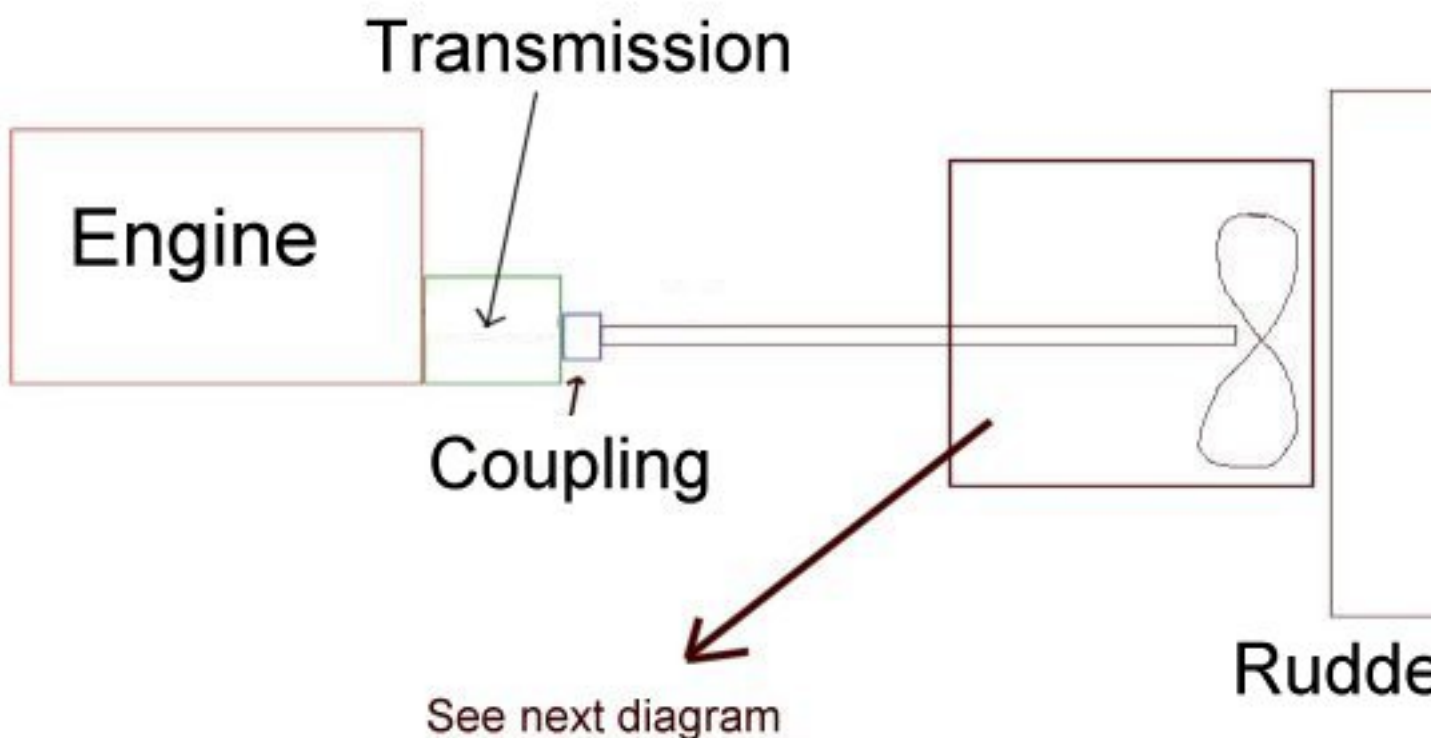
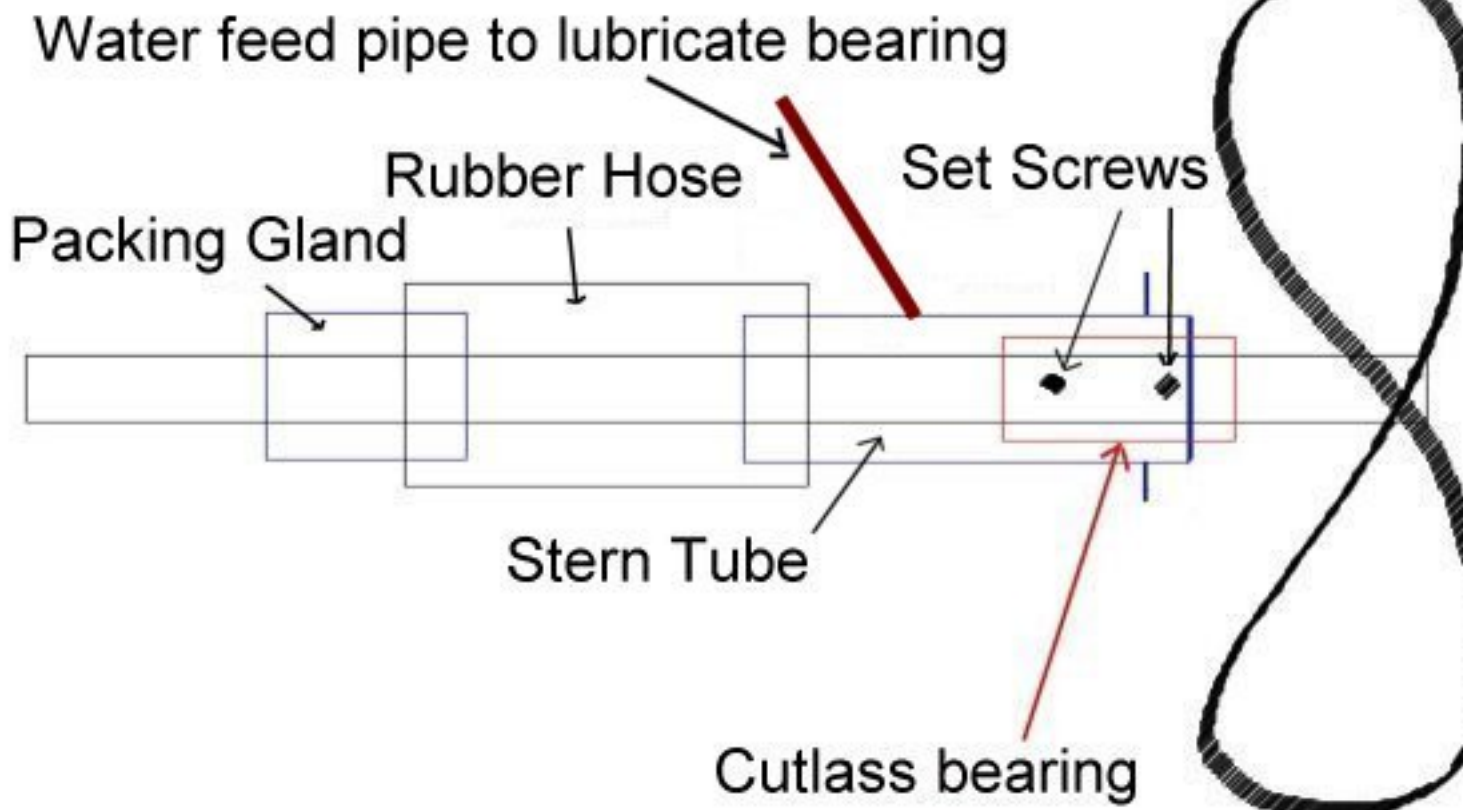
Diagram to aid the un-initiated;

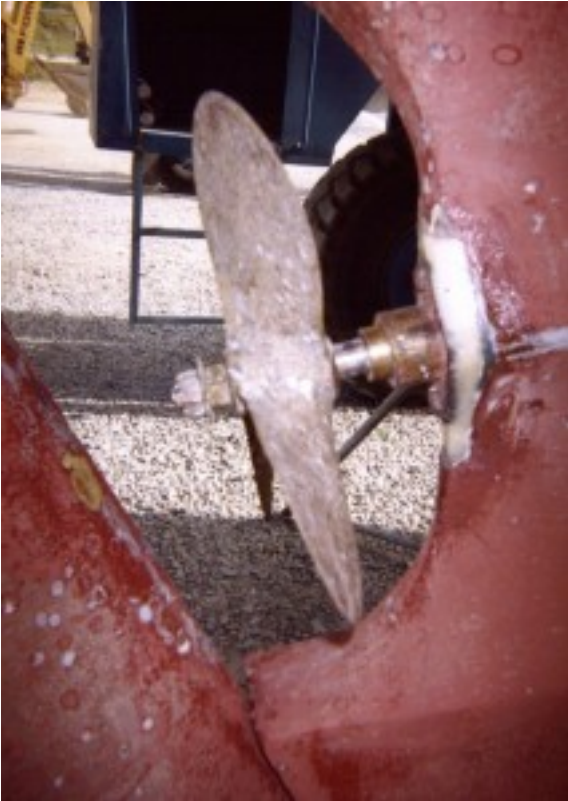
Figure 1.

The shaft on a DE38 will not come out backwards. The rudder is in the way. If your boat is set up differently - happy days. Never mind, all is not lost. If it won't go back it has to go forward - removing the transmission should give you enough distance. If you need to remove the shaft entirely you will have to drop the rudder (see Walt Smith for advice) or lift the engine.

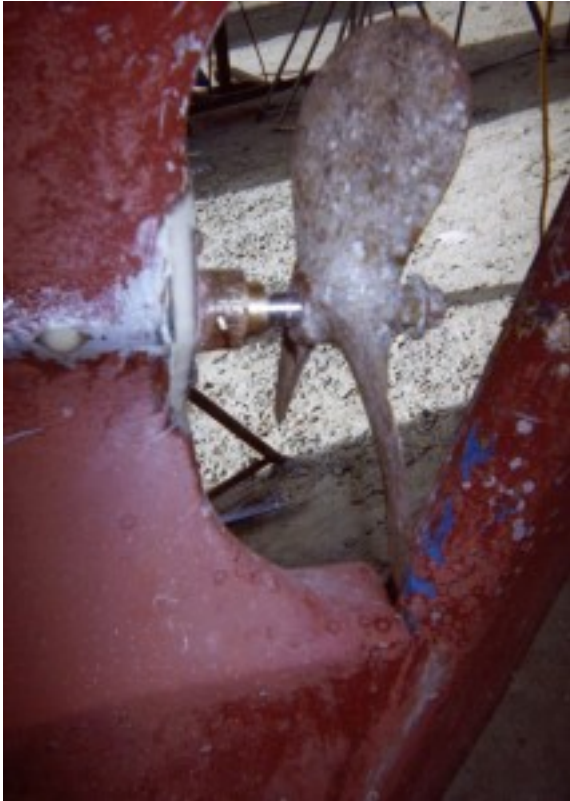
Figure 2.

1. In most cases you will not have to remove the shaft. Remove the transmission, and then move the shaft forward until it is clear of the cutlass bearing (after removing the prop of course).
2. Once you have moved the shaft forward you will be faced with a bronze stern tube held onto the hull by two lag bolts and a lot of 5200 or similar. Let this alone, it's a lovely piece of solid engineering.
3. Out of this you will see about 1/2 inch of the cutlass bearing. You will also notice a grub (set) screw on the port side - remove this. Exactly 2 ins forward of this grub screw (on the same side) is another one, hidden under the fiberglass. You can either move the whole stern tube back or drill through the fiberglass (I recommend drilling). Remove the second screw.

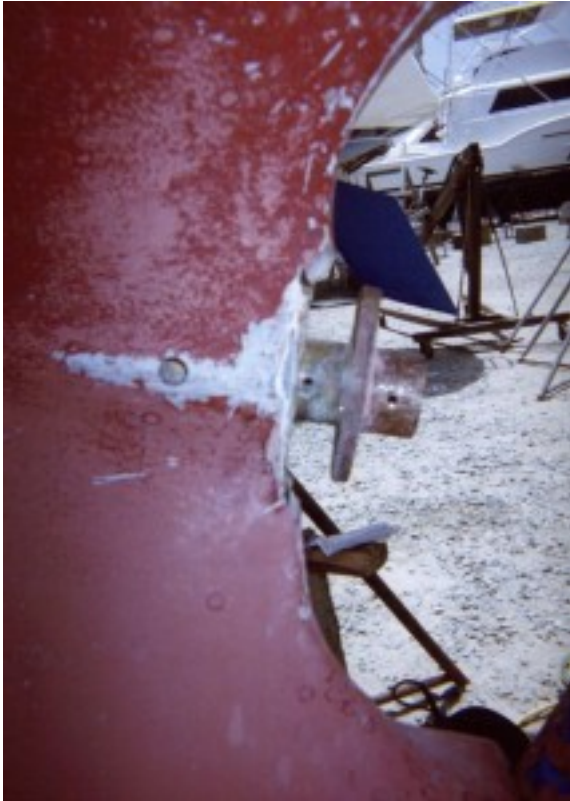
4. If you are lucky the cutlass bearing will twist out, if not, you will have to hacksaw through it - longitudinally - and then collapse it with a hammer and punch. Clean up the tube.

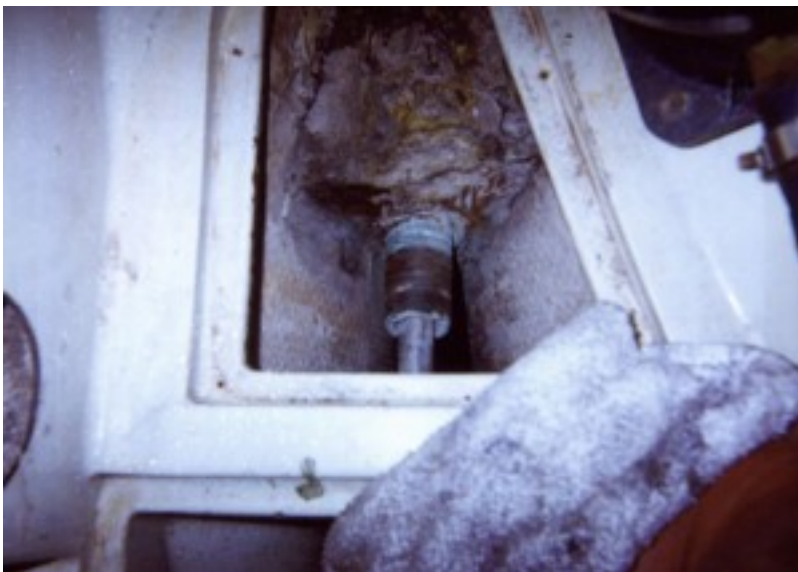
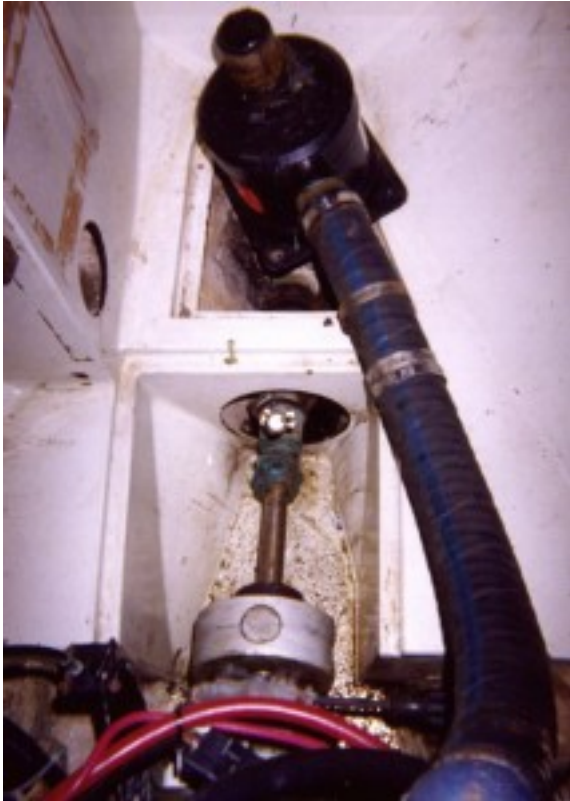
5. While you are there you may as well replace the rubber hose on the stern gland and replace the flax packing.

6. This will require the removal of the shaft coupling (depending on your setup) and it may be hard or easy depending on who installed the coupling in the first place. On Eriu the previous engineers had ignored any mention of an anti-seizing oil and succeeded in having the whole thing so frozen we had to cut it off. I replaced it with a [VETUS Bullflex](#) coupling flexible shaft coupler, which seems to do the trick.

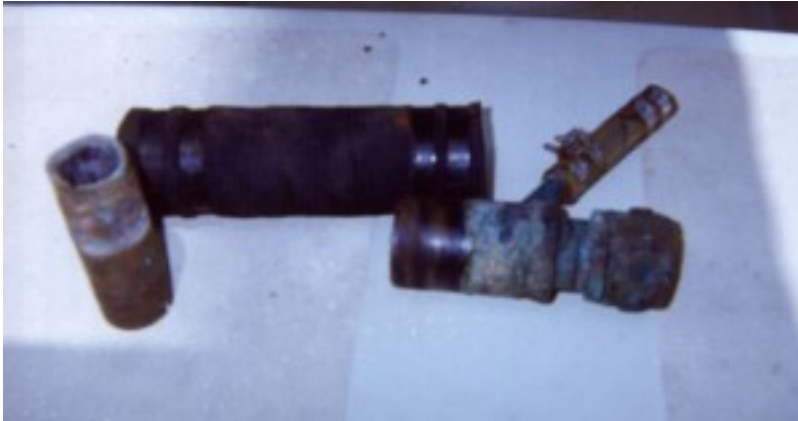
7. Move the shaft right aft until the end touches the rudder, remove the S/S clips on the stern seal and remove the hose and the front of the stern gland.

8. Clean up the bronze bit and replace the hose. Dig out the old packing from the cap, you should have at least 4 turns in there.

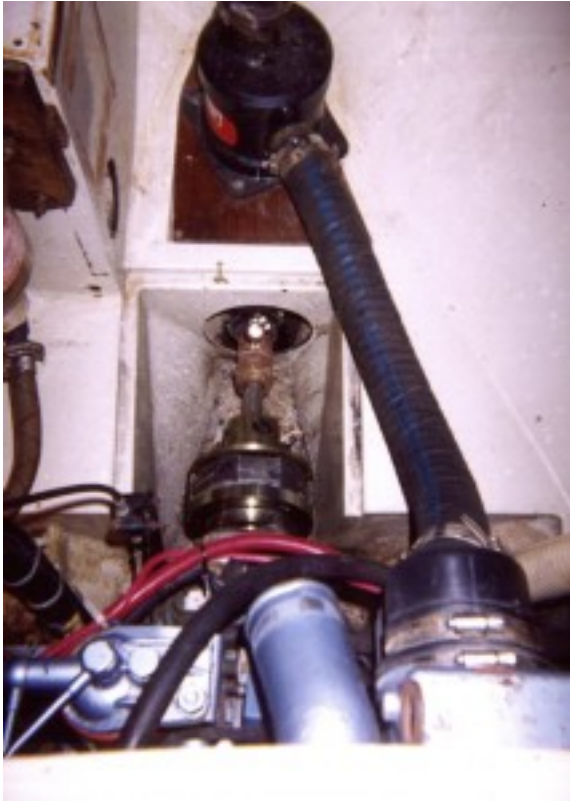
9. Clean out the water feed pipe, used for lubricating the cutlass bearing. Mine had been blocked off by the previous owner, which contributed to the wear on the cutlass bearing.

10. When fitting the new cutlass bearing my recommendation is to ignore the hidden grub (set) screw and drill and tap a new one in the exposed end of the stern tube, directly opposite the existing one.

11. Fit the new cutlass bearing, well greased with silicone, drill indentations for the set screw and screw them in with thread lock.

12. Refit the stern gland, rubber hose etc, using two high quality S/S rings on each end. Repack with packing. Reconnect the water feed pipe. Reinstall the coupling and transmission, connect everything up. Glass over hole for old grub screw, fair up any damage. Job done!
