Replacing the Head Plumbing on DE45 Eolian by Bob Salnick

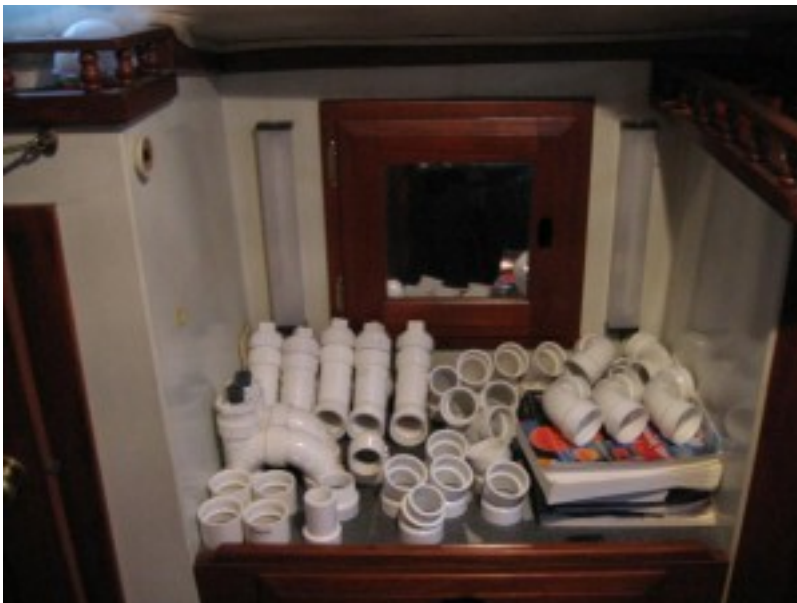
The first of many batches of about \$60 worth of fittings:

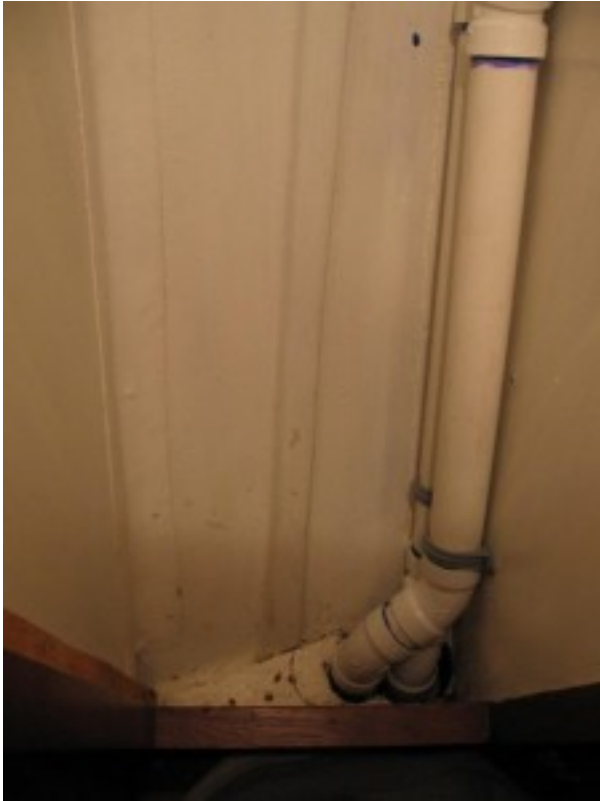
It takes me a long time to work out each run. Conservatively, I estimate that I spent an hour on each bend, working in cramped quarters, making sure that the pipe lead from the bend goes exactly where I want it to, and doesn't interfere with other runs. (There are two pipe runs tucked in that corner in the picture.)

So I make up a part of a run, studying the various combinations of fittings needed to make the corners and still trying to fit the triple criteria of:

- Use the minimum number of fittings because they cost a lot
- Make things neat - fit the piping into the available space tightly
- Make corners gradual - two 45s with a short length of pipe are better than a long sweep 90

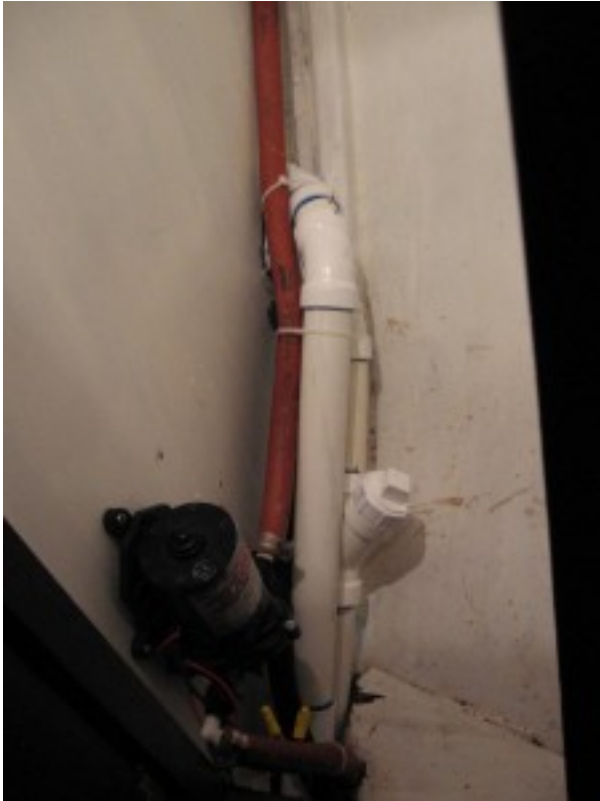
Also, there is the logistics of assembly. Put things together in the wrong order, and you literally "can't get there from here". Finally, the small spaces get you. For example, the inside dimension of the forward head sink vanity, thru which two runs needed to pass, is 27". Outside dimension, and leaving enough to cement on a fitting on the end, is 31". But because of the cramped spaces, there is no way to get a 31" piece of pipe in there. So, you cut it in half, and join it with a coupling inside the cabinet. Standing on your head. Working at arm's length in a small space. Breathing in the PVC cement fumes.

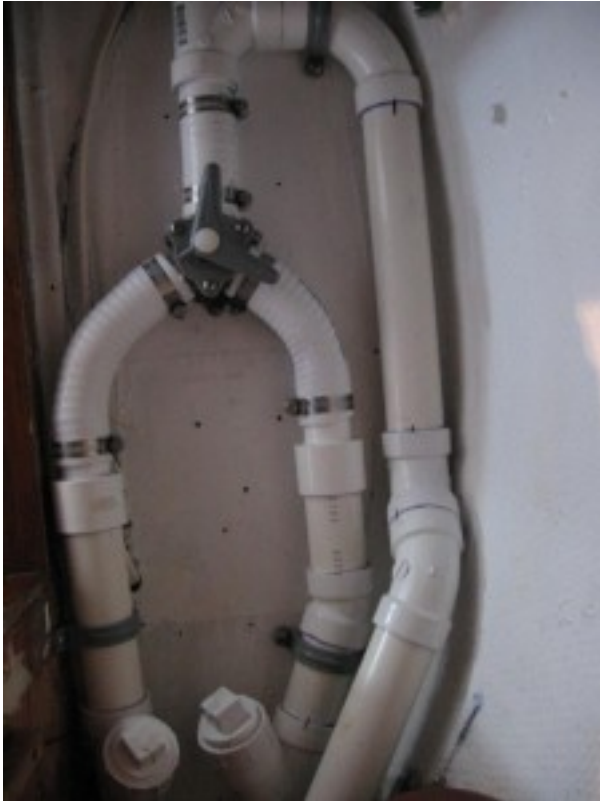
Also, because I can, I included cleanouts (wyes with screw-out plugs) where it made sense (at least one on each pipe run). These allow access with a sewer snake, but also provide a port which can be used to add hydrochloric acid to dissolve the carbonates which form as a reaction product between urine and seawater. I decided that all these cleanouts need to be above the waterline, so the plugs can be safely removed even if the seacocks are not closed.

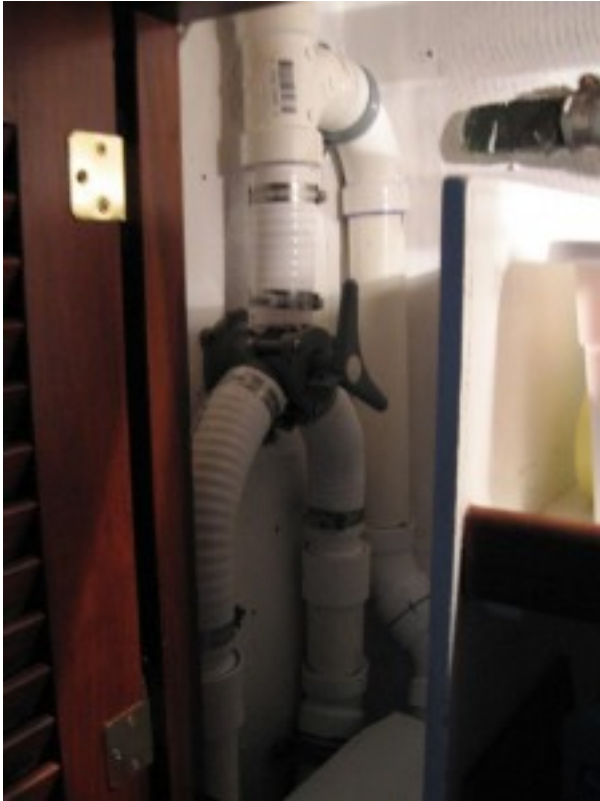
Finally, I used PVC fittings to make improved versions of the vented loops. The original bronze ones were only 1" internal diameter, and were mostly clogged with carbonates anyway. Mine are 1.5" diameter all the way thru, and in addition provide a disengaging zone below the vent line so that it is less likely that sewage will enter that vent line.

(Vented loops are required because the heads would directly communicate with the sea when the overboard discharge line is open - and the heads are located below the waterline. Without the vented loop, a siphon could start, with the ocean filling the boat thru the head. The vented loop is a siphon breaker.)
