Cabin Window Upgrade-Alternate

Michael Homsany and Kendra Pinsker

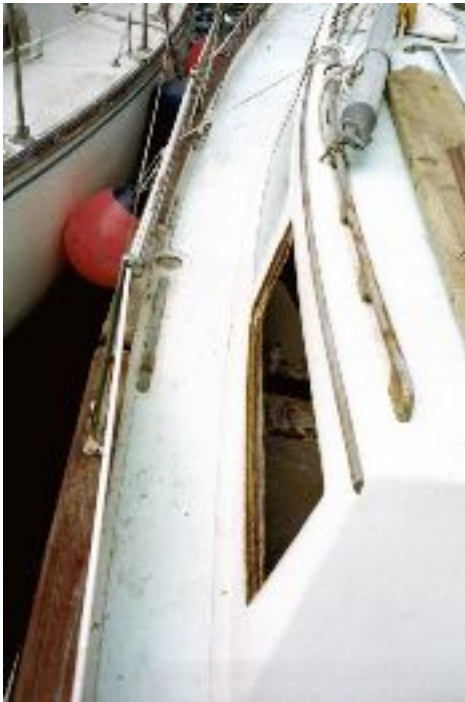
Port removed. Foam core dug out approx. 7/16".

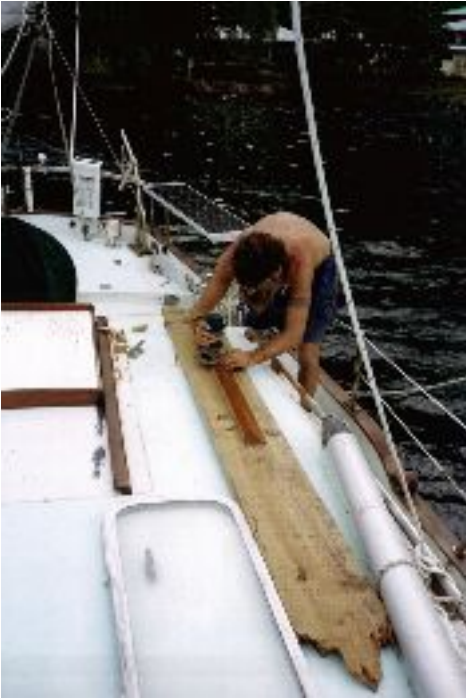
Cutting rabbets into teak.

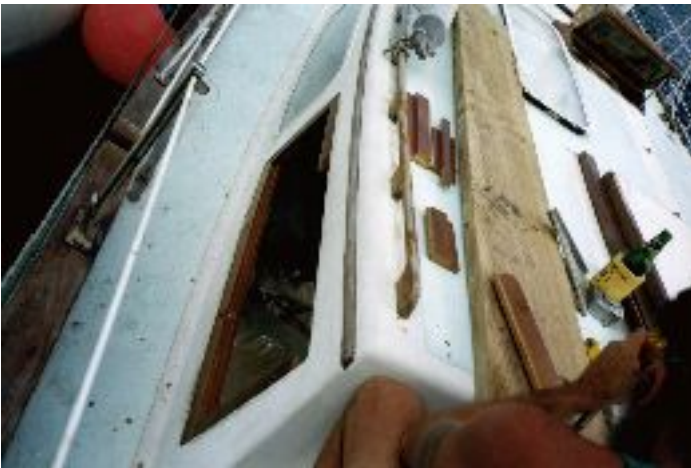
Fitting in 10 pieces. Note notches for centre vertical.

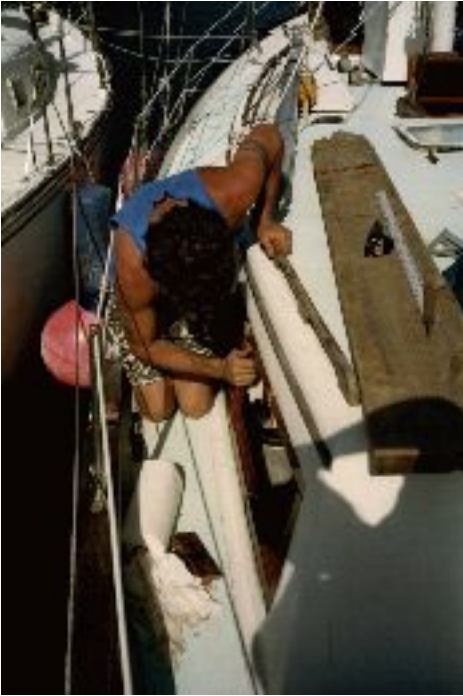
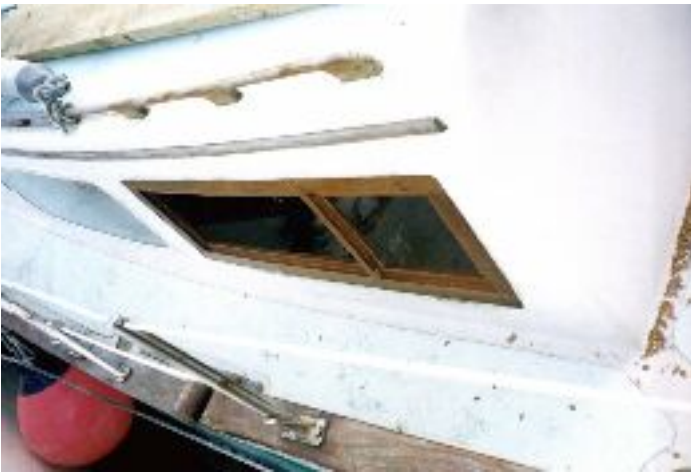
Fitting Pieces

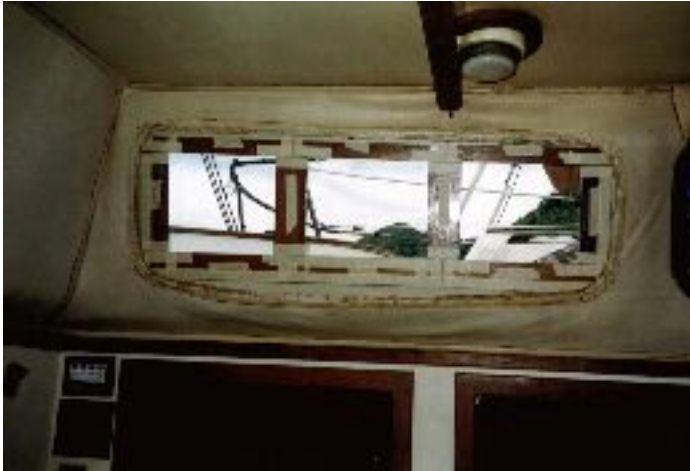
Before applying 5200 glue (no screws)

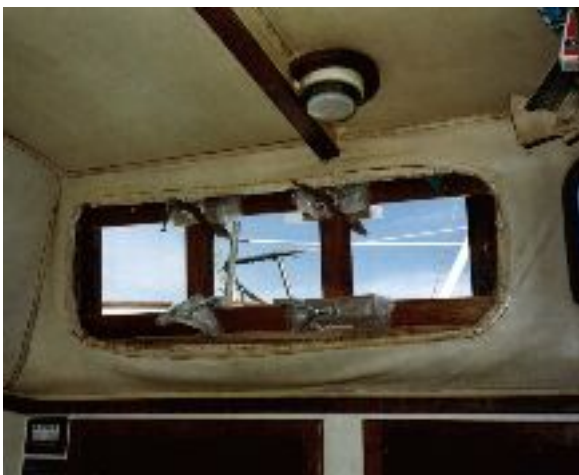
Clamped. Except for vertical dividers pieces are held in place by the sections interlocking.

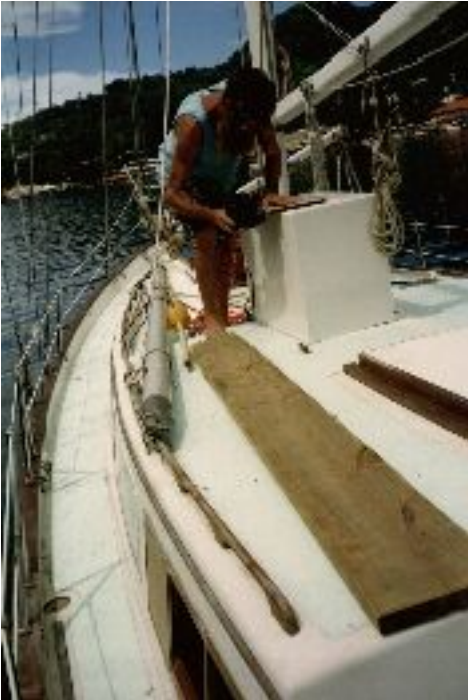
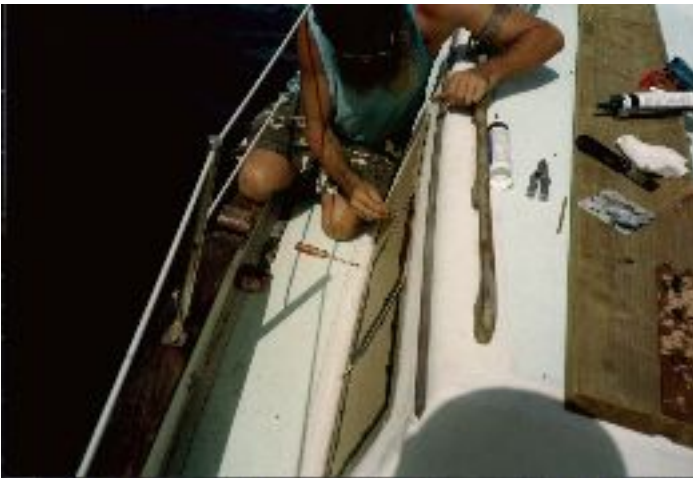
Fitting Plexi
Plexy after bedding
