## s/v Valkyr: Dorade Vents

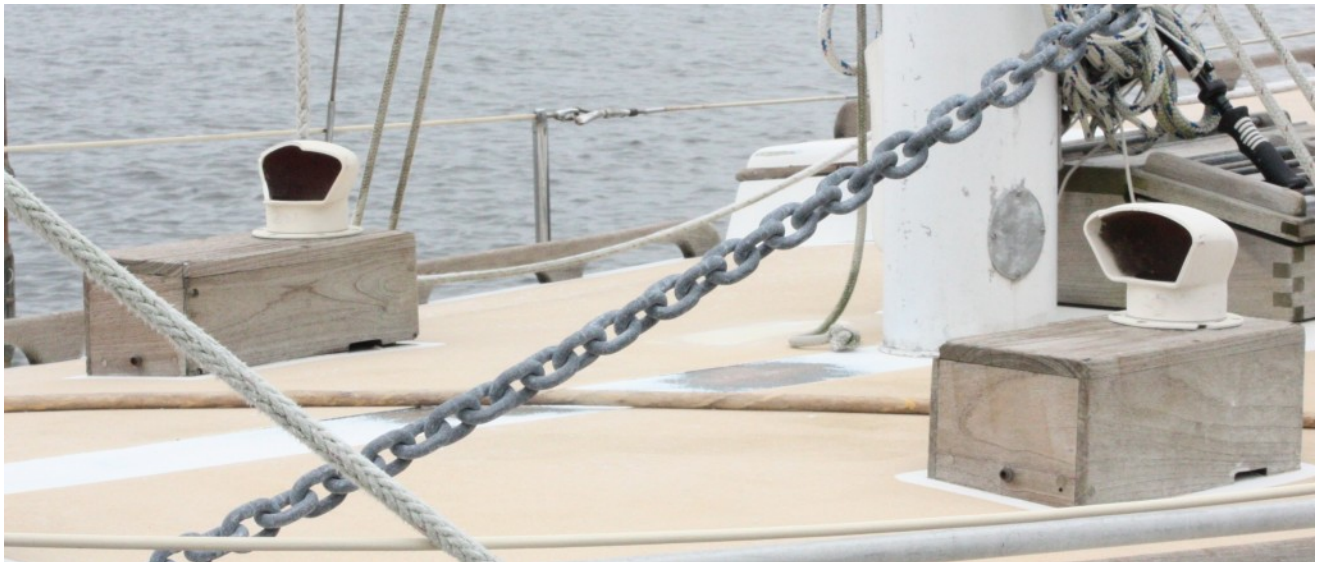
The plastic cowls on Valkyr's dorade vents had become very discolored and brittle with large chunks broken out.

As a last project before we left the boat yesterday we decided to replace the cowls on the dorade boxes. Angela who we bought the boat from had already bought a couple Nicro plastic cowls.. They were the exact same cowl as was originally installed on Valkyr so all the holes perfectly matched for the mounting screws. We thought it would take a few minutes to do this. Two hours later we actually finished. The screws holding the cowls on were all bronze with a nut on the opposite side. So we ended up taking the entire top lid off the dorade box to get to the underside. I'm very glad we did. There was really nasty stuff in the dorade boxes. Mud dobbers had been living in one years ago and left behind about a two cups of dirt that was holding moisture. The other dorade box was a cockroach motel. Shop vac to the rescue.. it sucks dirt and cockroaches equally well.

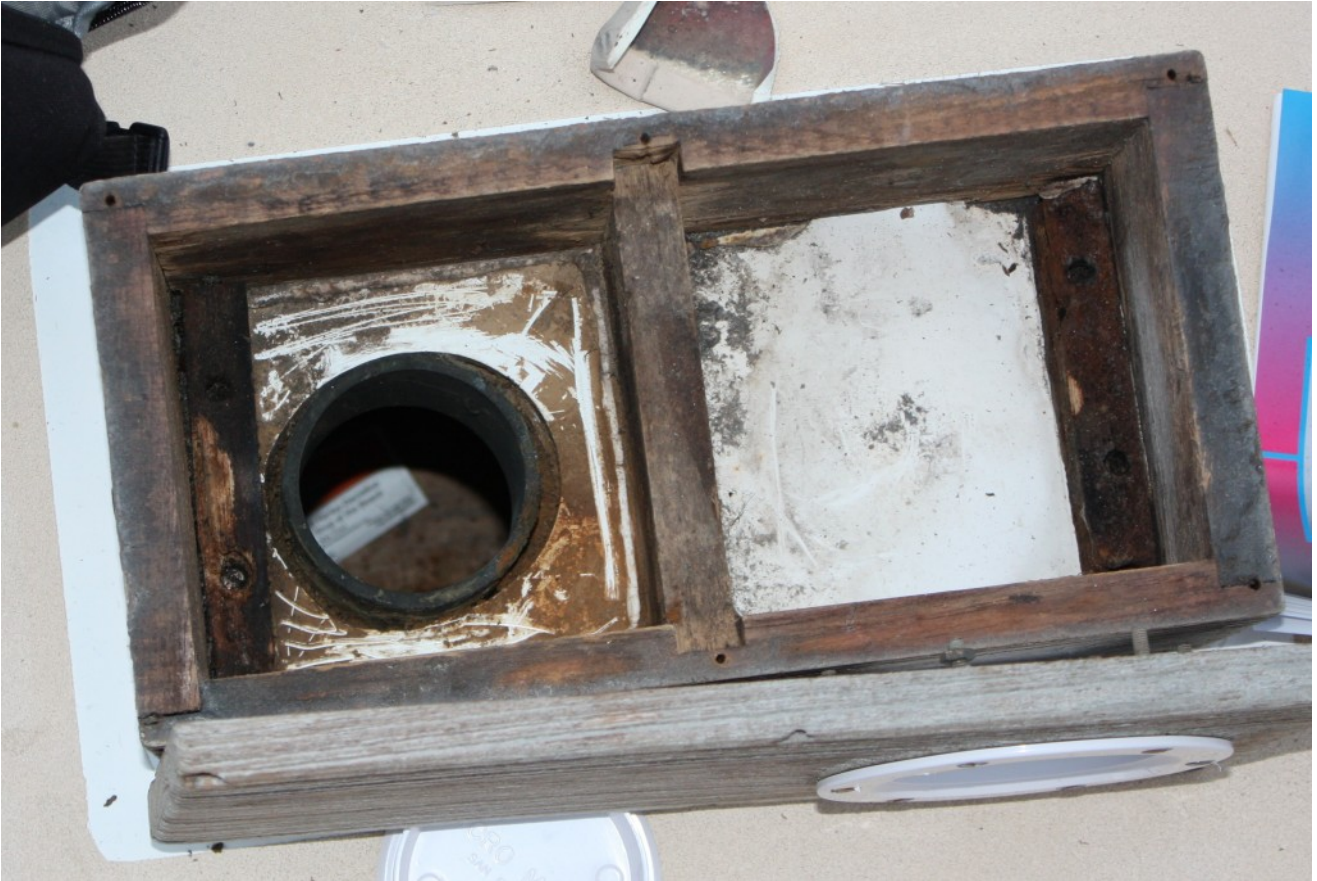
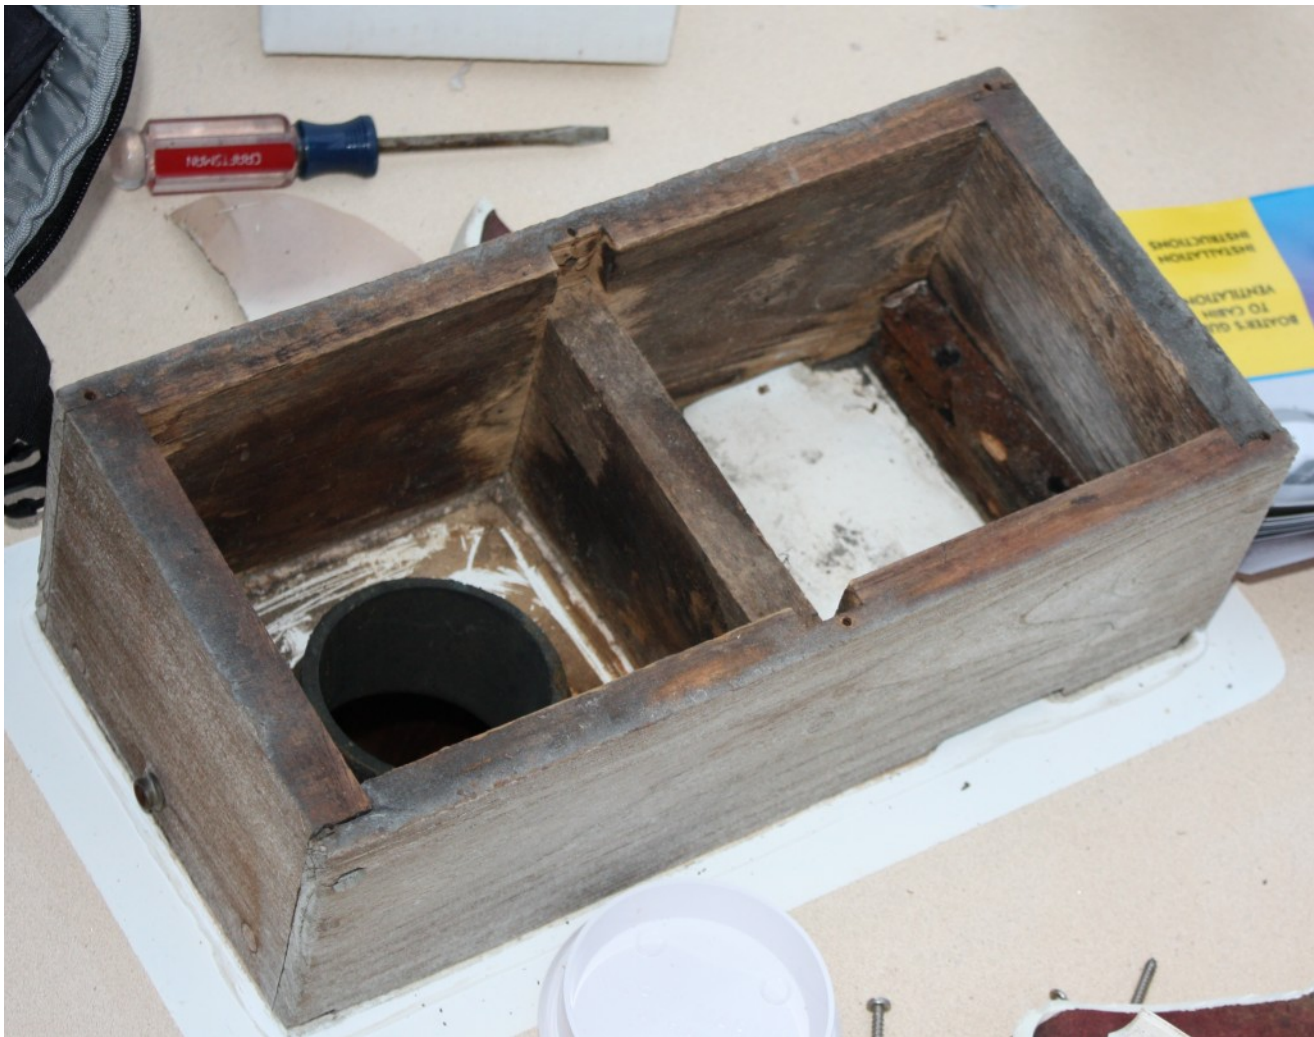
Also as you can see in the above images the wood in the cross pieces the box is attached to on deck is starting to rot out.

To fix or change.. Longer pipe through deck and one that can be sealed water tight. Fix rotted sections of boxes. Check core of deck. Seal pipe in better. Varnish boxes.

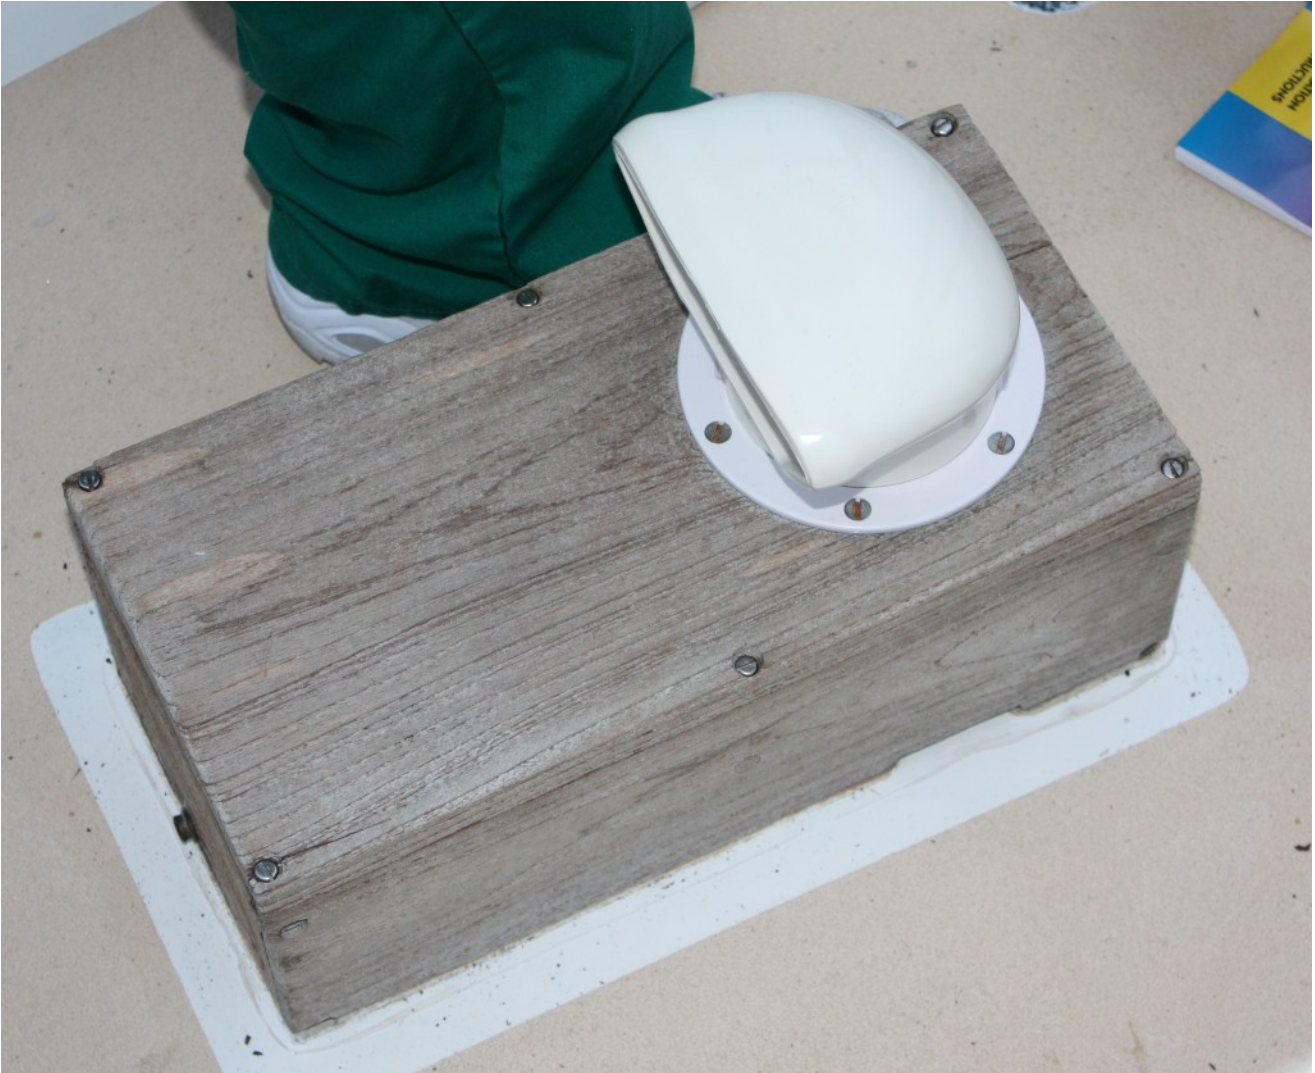
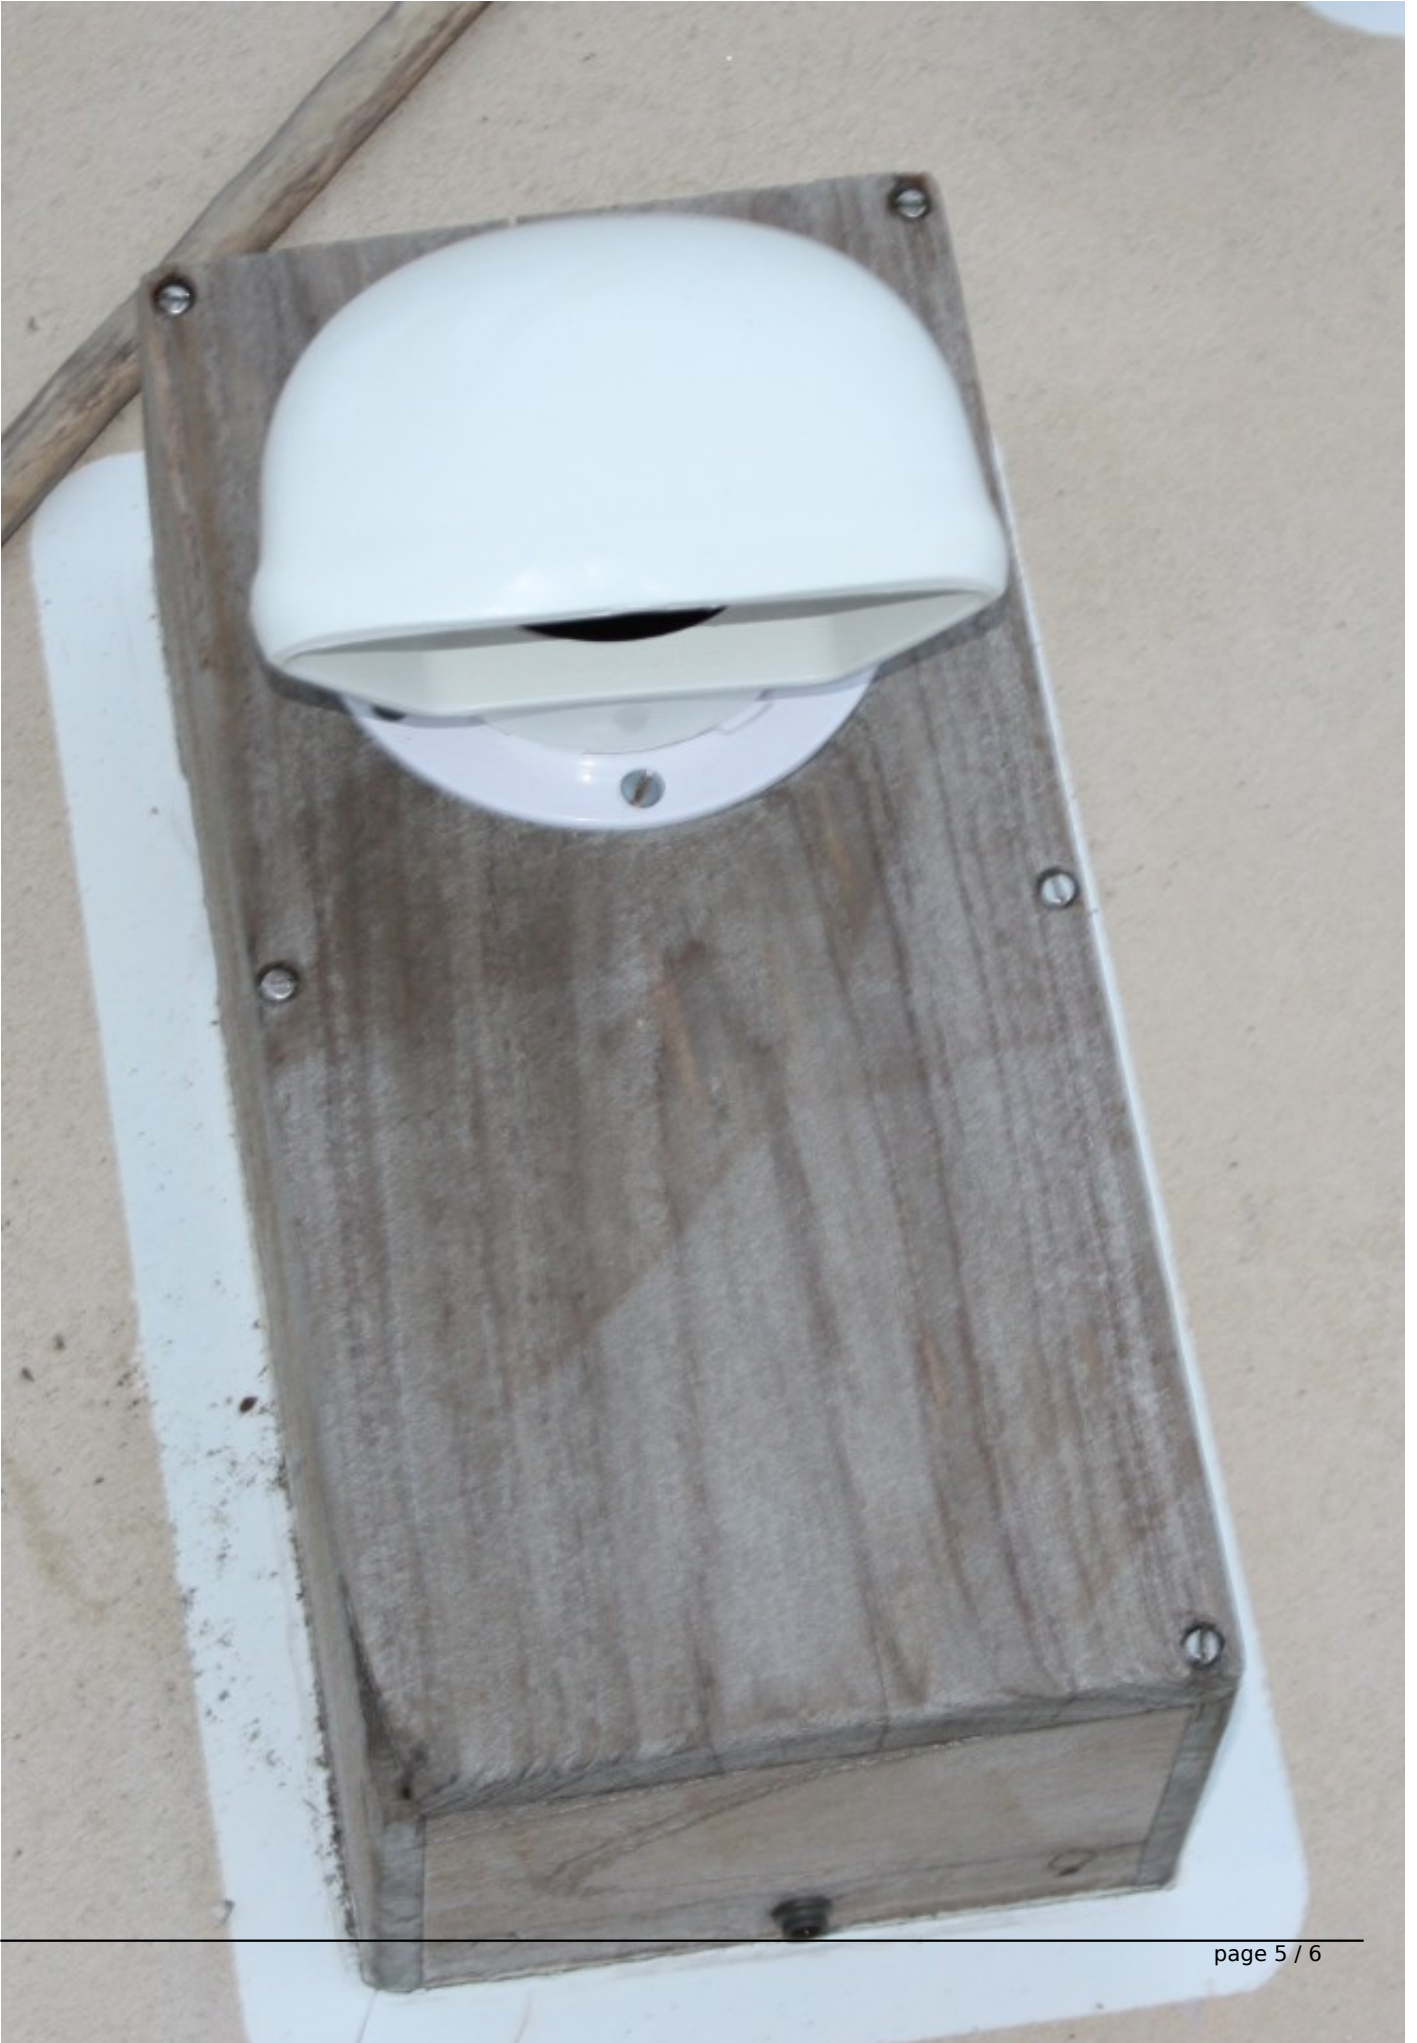
The design of the current opening through the deck leaves something to be desired. It is a flanged piece of pipe that is screwed to the underside of the deck and comes up through a hole cut through the deck. It only extends about an inch above deck level. It also doesn't have any way of sealing it closed. Under most conditions it is probably adequate but if the boat ever took solid green water over that area it would be possible for it to work its way through the dorade box and into the boat. My second issue is the hole cut through the deck. I need to pull the pipe out of the hold so I can get to the core. I'm not sure when they cut the hole that they sealed the core. It is open from on deck as the hole for the pipe is about 1/4 inch larger all around than the pipe with flange any water or moisture that gets in there will drain into the the core if it is open.
